Trouble Under Foot

A case study of the restoration of a concrete structure forming a crawlspace and supporting two-story brick townhome condominiums above.

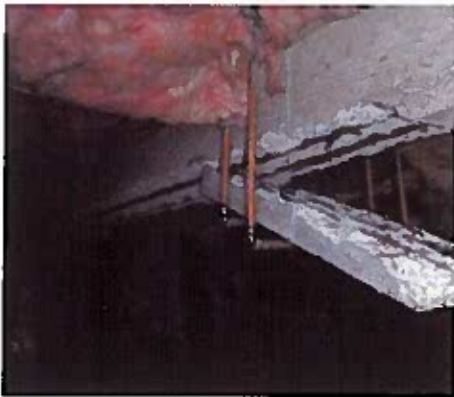
During a visual survey of a building slated for an underpinning repair project, it was discovered that there was significant concrete deterioration to many of the structural elements within the crawlspaces. Large sections of beams and columns had spalled, exposing embedded reinforcement that was severely corroded. The ability of the structure to support the required load was compromised due to the deterioration. Shoring was immediately installed and the owner retained an engineer to investigate the concrete failure, establish the condition of the remaining structures, determine the cause(s) of the concrete deterioration, and provide recommendations for repairs of the involved elements.

The engineer's investigation revealed that high levels of chloride and carbonation of the concrete had penetrated up to three inches, a depth that exceeded the concrete cover of the embedded steel reinforcement. Carbonation reduces the concrete's ability to protect the reinforcement from corrosion, and chlorides accelerate corrosion. To have both of these conditions present presented a major problem and would need to be addressed to protect the structures from future deterioration.

Figure 1: Typical damage to the concrete members found during the engineer's condition survey.

The alternative approach, which was selected by the owner, was to remove just the currently degraded concrete from the beams and columns and leave the sound concrete in place. Exposed reinforcement was cleaned and coated with a corrosion-inhibiting paint. A high quality repair mortar was used to replace the excised concrete. Outside of the patch areas, sacrificial zinc anodes were installed in a prescribed pattern to combat corrosion of the reinforcement. Once all repair work was complete, a corrosion inhibiting treatment was applied to all exposed concrete surfaces. Additionally, the soil within the crawlspaces was covered with plastic to minimize water-vapor drive and fans were installed to circulate air and help further control moisture.

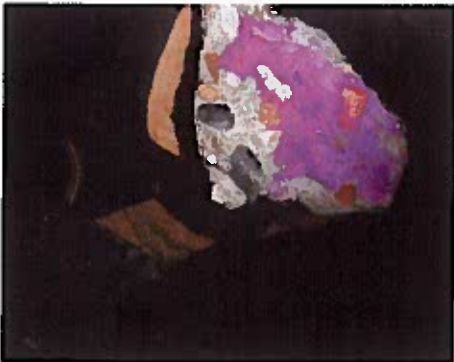
Figure 2: Pink concrete is toward the center of the member and not contaminated by carbonation.

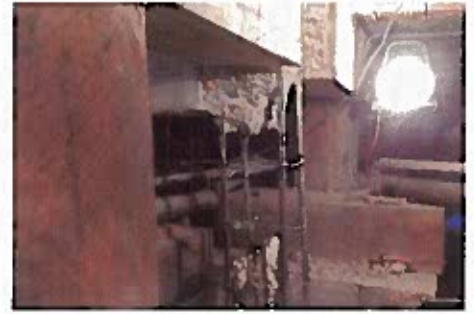
Figure 3: This photograph shows what is left of a concrete columns after all deficient was removed.

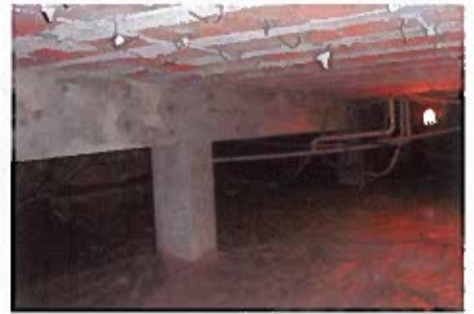
Figure 4: The crawlspace was cleaned and covered with plastic sheeting following the repairs to the concrete members.
