# CAPITAL RESERVE STUDY

July 2016

**THE FALLSWOOD II CONDOMINIUM ASSOCIATION**

Hamill Road, The Village of Cross Keys

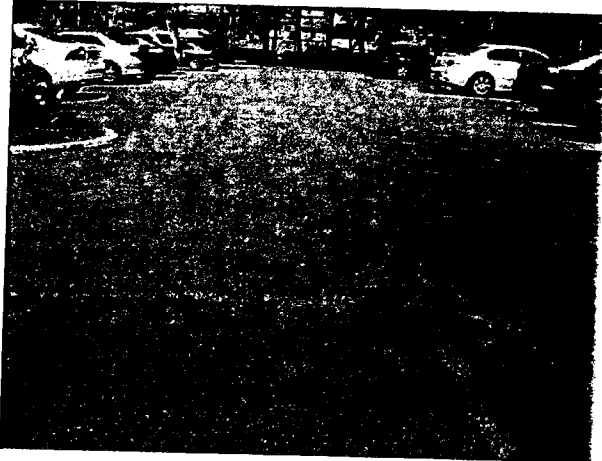
Photo 1: Current condition of the asphalt parking lot of the Fallswood II Condominium. It is recommended that the asphalt gets rejuvenated every 5-8 years to prolong its useful life.

It is recommended that the community rejuvenate the asphalt soon as a means of preventative maintenance. The rejuvenation is a process that is recommended every 5-8 years to prolong the useful life of the asphalt by returning elasticity to the asphalt so that it can contract and expand with the change of weather conditions (See section IV. A. photos 1 & 2).

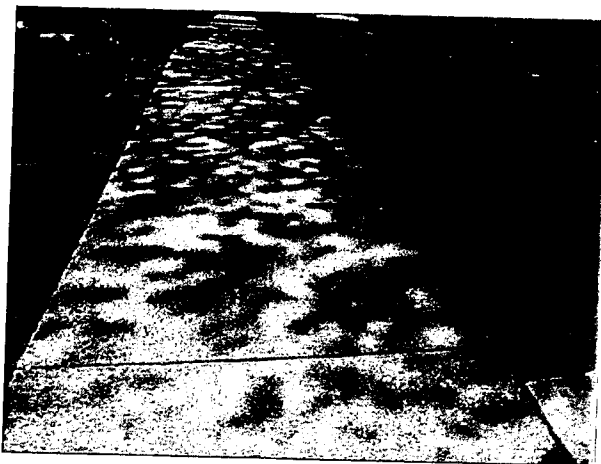
Photo 3: Current condition of concrete observed at the Fallswood II Condominium.

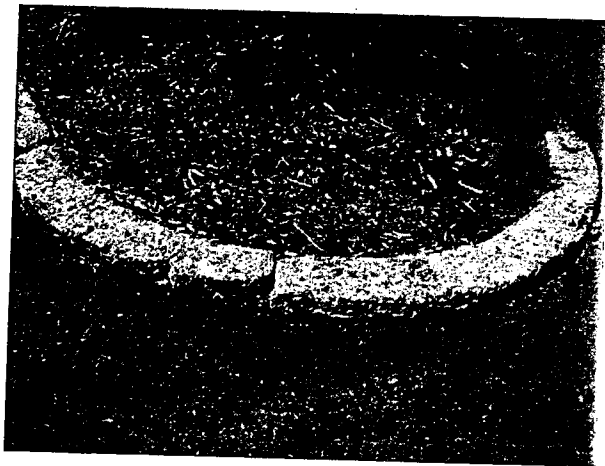
Photo 7: Aggregated concrete curbing was observed to be in need of repair from likely snow removal and normal aging. Cracks should be sealed to prevent water infiltration and further deterioration.

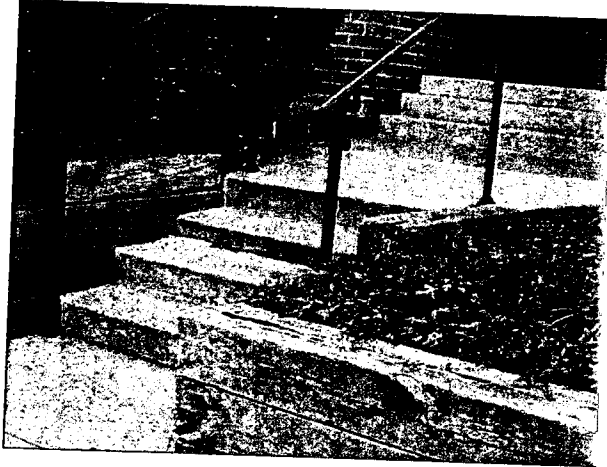
The metal railing throughout the community have been properly maintained and outlived their useful life. There were no signs of rusting or physical failure, however, it is recommended that sections of railing be scheduled to be replaced in phases to offset total replacement costs (See section III. F. photo 9).

Photo 9: Typical metal railing observed in the Fallswood II community.

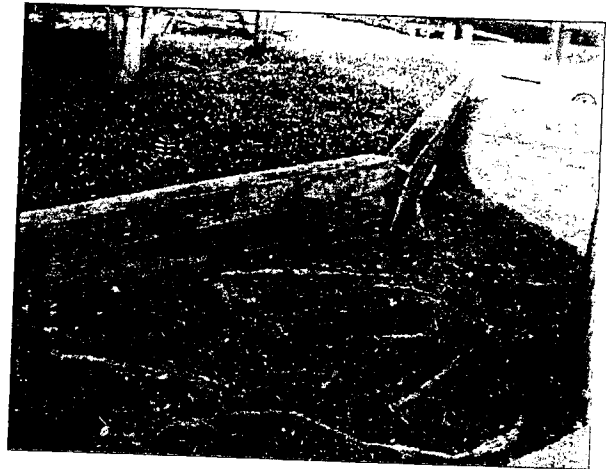
Photo 10: Current condition of landscape retaining walls.

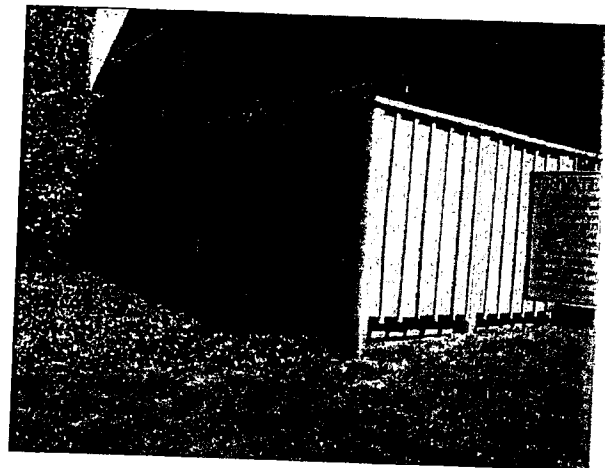
Photo 12: Typical PT fencing observed at Fallswood II Condominium. Fencing has been painted to prolong its useful life.

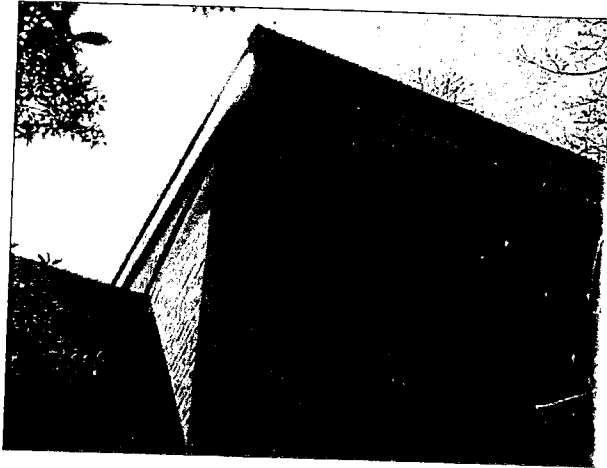
Photo 13: Typical gutter & downspout system at Fallswood II Condominium.

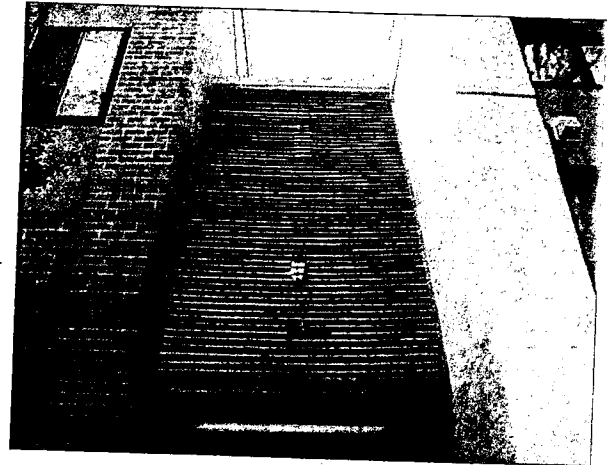
Photo 14: Entrance louvers were observed to be in need of maintenance.

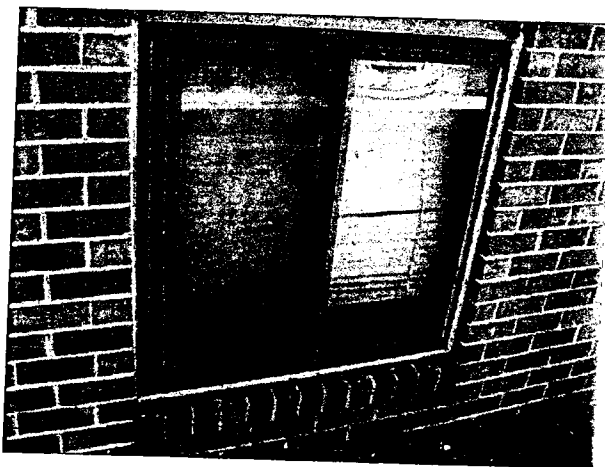
The common windows in the laundry rooms and mechanical rooms were observed to be nearing their useful life and should be scheduled for replacement soon (See section III. F. photo 15).

Photo 15: Common area windows were observed to be at the end of their useful life and should be scheduled for replacement.

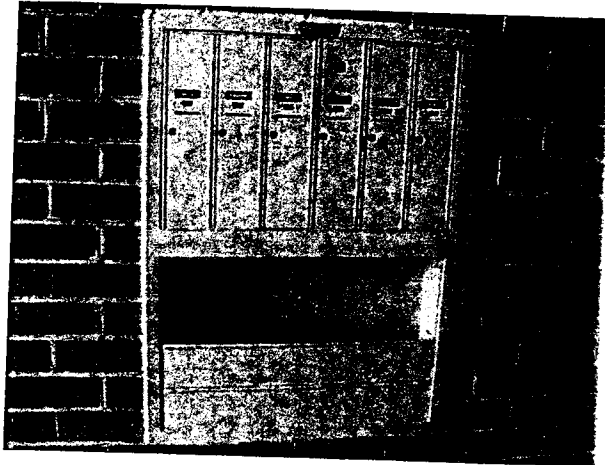
Photo 17: Typical mailbox set observed in each building entrance at Fallswood II Condominium.

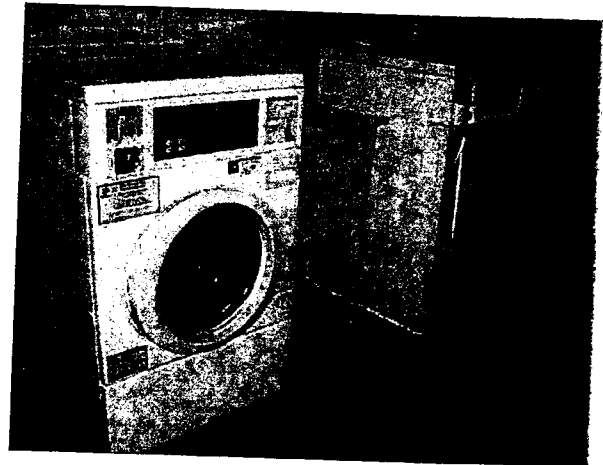
Photo 18: Typical washer and dryer found in all 11 condominium buildings

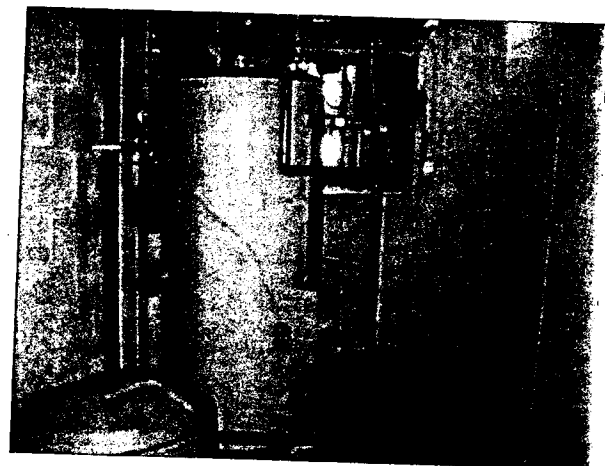
Photo 20: Typical hot water heater found in the community. 2 units are nearing the end of their useful life and should be scheduled for replacement.
