By Nicholas Henn, P.E.

# Wind Damage

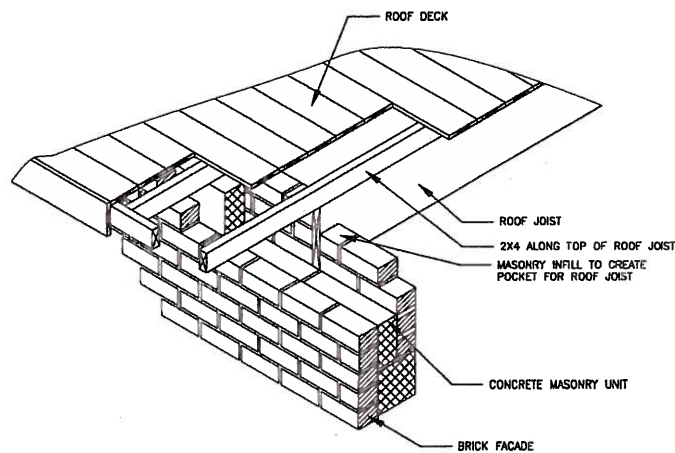
Figure : Original framing condition with roof joists set in pockets along the bearing wall, with no mechanical connection.

While the configuration of the underlying structure was not revealed by removing the membrane, a review of the construction documents would have shown that the roof structure was not attached to the bearing walls. This condition would be unacceptable under current building codes. The design of the replacement roof should have included an evaluation of the structure to determine how a change in membrane attachment would affect the ability of the roof to resist uplift, and measures to provide adequate resistance.

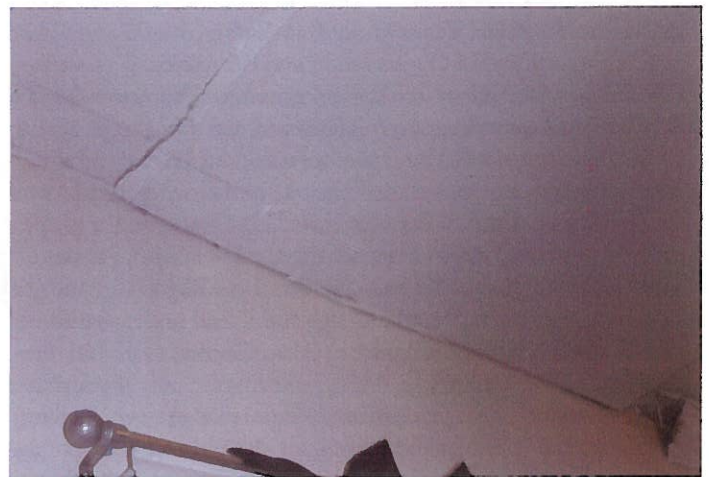
Figure 2: damage to the interior finishes along the ceiling from the roof failure.

It's believed that during the involved wind event the uplift force along the roof edge was greater than what the fastening of the 2x4's along the roof joists could withstand. The fasteners (nails) were overloaded, they pulled out and the roof peeled back. The force was also sufficient to move the joists in their pockets, as evidenced by damage to interior drywall and trim elements.
