### Decoding Wall Cracks: Lessons Learned from Last Summer's Earthquake By Christopher W. Carlson, Engineering and Technical Consultants, Inc.

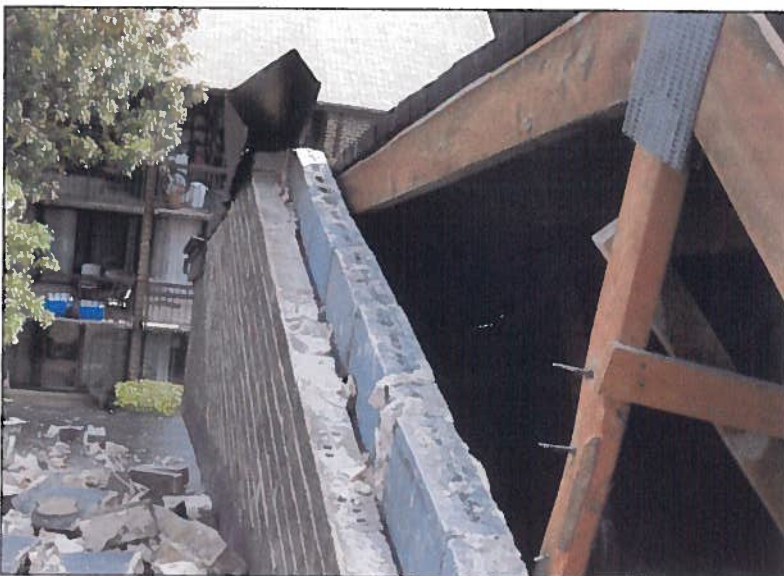
*Photo 1: Masonry dislodged from a pitched roof truss.*

done to masonry gable walls between and on the ends of buildings. Large sections of masonry dislodged from pitched roof trusses and either crashed through the roof or stood precariously out of plumb (by as much as four inches). The masonry wall did not have any ties back to the structure above the adjoining roofline. As a result, the concrete masonry unit (CMU) backup wall and brick facing comprised a cantilever sticking up (unsupported) about seven feet. These buildings had weathered many storms over the years, but no event was strong enough to reveal this original construction defect (see photos 1 and 2).

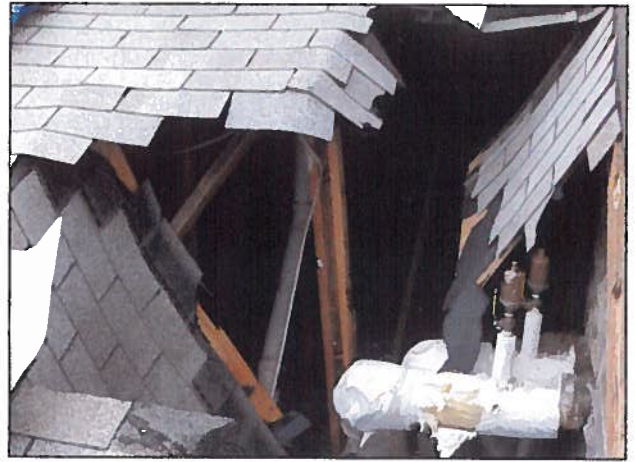
**Photo 2: Masonry crashes through the roof following earthquake.**

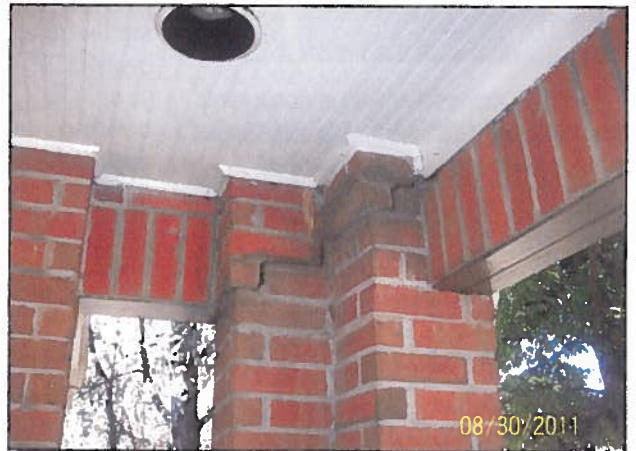
Another example is a low-rise condominium complex, which experienced cracking and displacement at the connection between the masonry columns of a porch and the end wall. Prior to the earthquake, minor staircase cracking was observed. After the earthquake, the cracks were much wider and the masonry columns had pulled away from the end wall (see photo 4).

ETC determined that there were no footings below the porch columns, which jeopardized the structural integrity of the building from the day it was built. The minor cracking observed prior to the earthquake should have been a telltale sign that there was something wrong. If this problem had been investigated further and subsequently repaired, major damage could have been averted and the structure could have been salvaged.

**Photo 4: Masonry columns pulled away from an end wall.**

Unfortunately, the cost of repairs was too high. The owners opted instead to remove the porch.

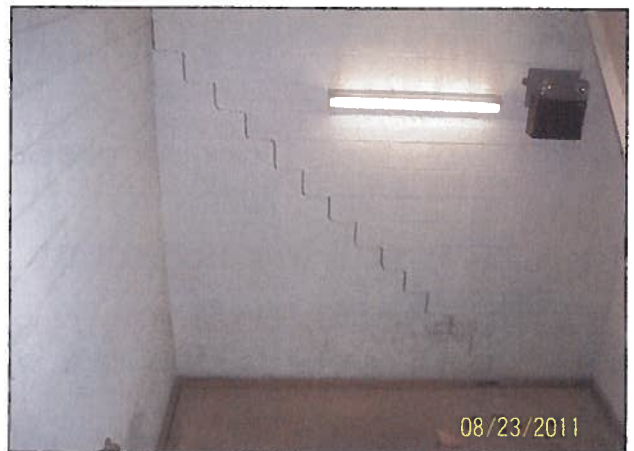
Our team was also asked to inspect a multilevel, precast concrete parking garage located at a shopping mall. It turned out that the garage had structural defects that the earthquake exposed. We found damage to the interior stairwells formed with CMUs. The rigid stairwell towers, used to stabilize the structure, cracked in shear, as they could not resist the lateral load induced by the ground motion (see photo 5). In other parts of the stairwells, finished drywall exhibited horizontal cracking. From this, we concluded that the stairwell walls lacked adequate detailing and/or reinforcement, which was a preexisting design flaw.

**Photo 5: Rigid stairwell towers, used to stabilize the structure, cracked in sheer because they could not withstand the quake's lateral loads.**

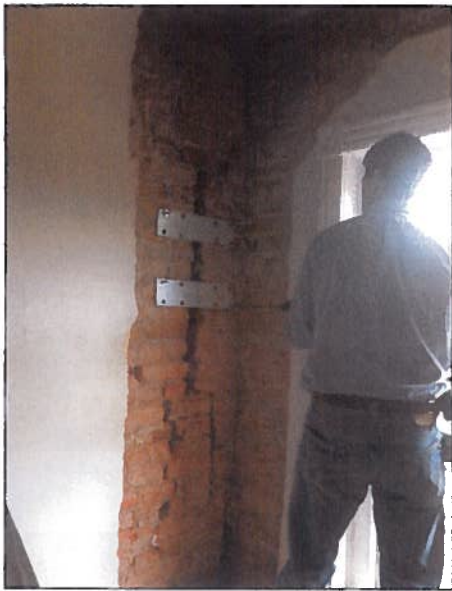
A hundred year old, three-story row house structure with thick brick walls had large sections of the front façade rotated out of plumb by nearly three inches. The greatest displacement was where abutting and reinforcing masonry walls had become disconnected from the façade. Those cracks were not new, but they widened significantly after being shaken. The cracks had been filled with spackling over the years, but were never properly repaired (see photo 3). Consequently, to repair the building, large portions of the façade will need to be removed and reconstructed.

**Photo 3: Cracks filled with spackle could not withstand last summer's earthquake. Temporary supports applied.**
