Retaining a Landmark

The Watergate at Landmark Community Association in Alexandria, Va., a leader in local community living, management and improvement even as it approaches its 40th birthday, recently took steps to restore and improve the retaining walls surrounding its central architectural feature—the outdoor swimming pool and entertainment complex.

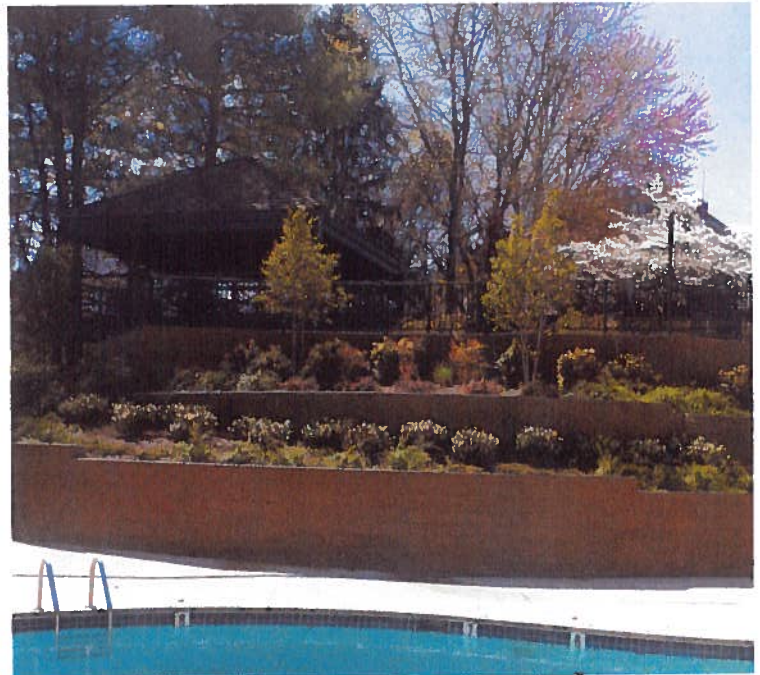
By 2010, portions of the walls were leaning, corners were separating and the timbers were deteriorating. These walls well exceeded their intended usefulness; typical service life for this type of wall is about 20 years. There wasn't any visible indication of drainage systems to control water pressure or water accumula-

tion behind the walls, indicating potential structural deficiencies too.

In addition, the walls became overgrown by unmanageable landscaping over the years. Instead of being a focal point of the pool area, the walls were hidden from view. Based on their age and condition, the walls needed to be replaced, but the community also wanted to maintain the layout and general appearance of the original design.

After careful consideration of alternatives, the board selected new concrete walls because they would encroach the least on the pool deck. The board—in an effort to overcome appearance issues—decided to use form liners that create a timber texture on the face of the walls and tint or stain the concrete to emulate the color of wood.

After the area was cleared, more than 100 tiebacks were used to anchor the new walls. Some were installed to depths of

more than 60 feet. The tieback shafts were capped with brackets, which were encased in the new concrete walls.
