GREENS AT LEISURE WORLD

15107 (Building #2) Interlachen Drive
Silver Spring, MD

ROOF REPLACEMENT PROJECT

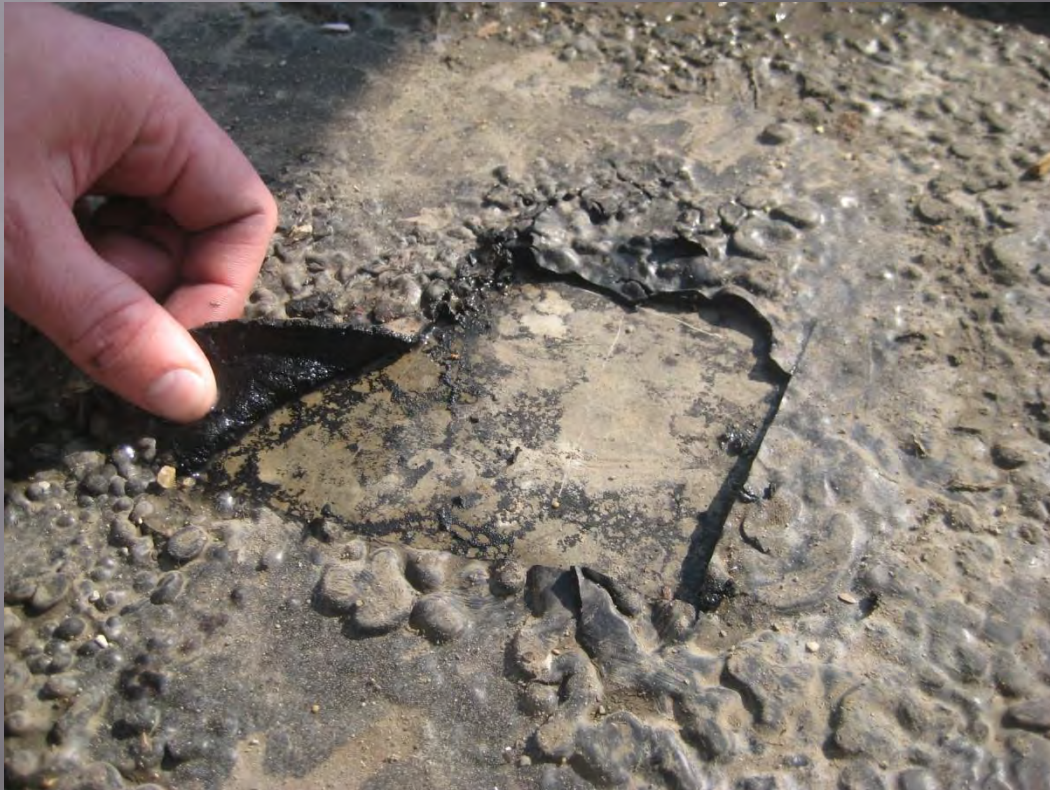
- Adhesion failure of roof membrane

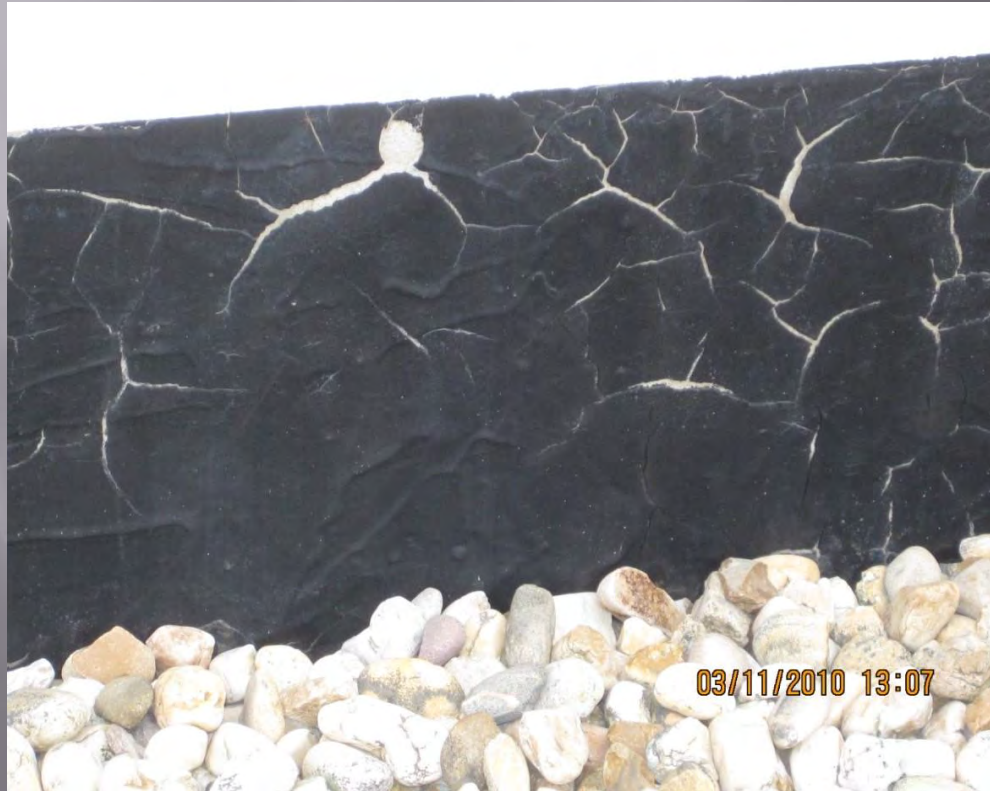
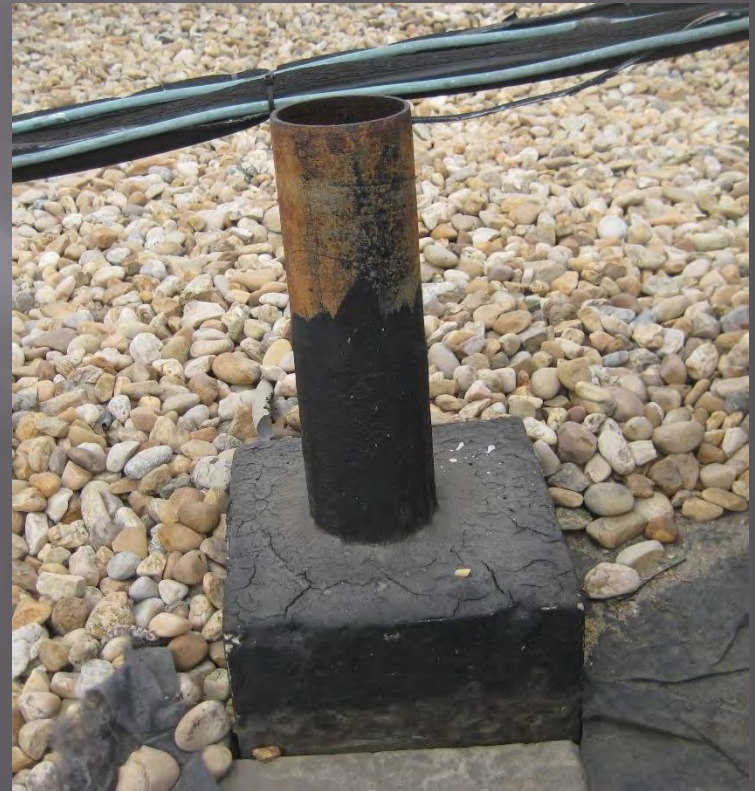
- Deterioration of exposed membrane

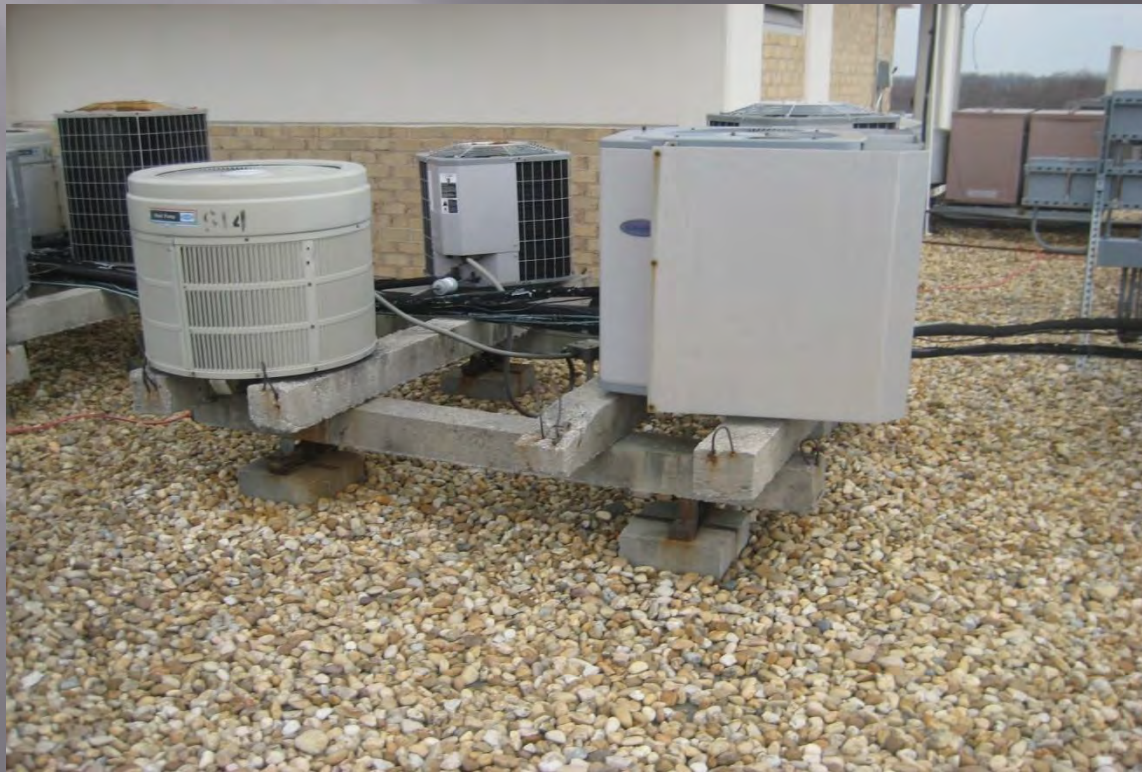
- 250 heat pumps (from new to 30 years old)

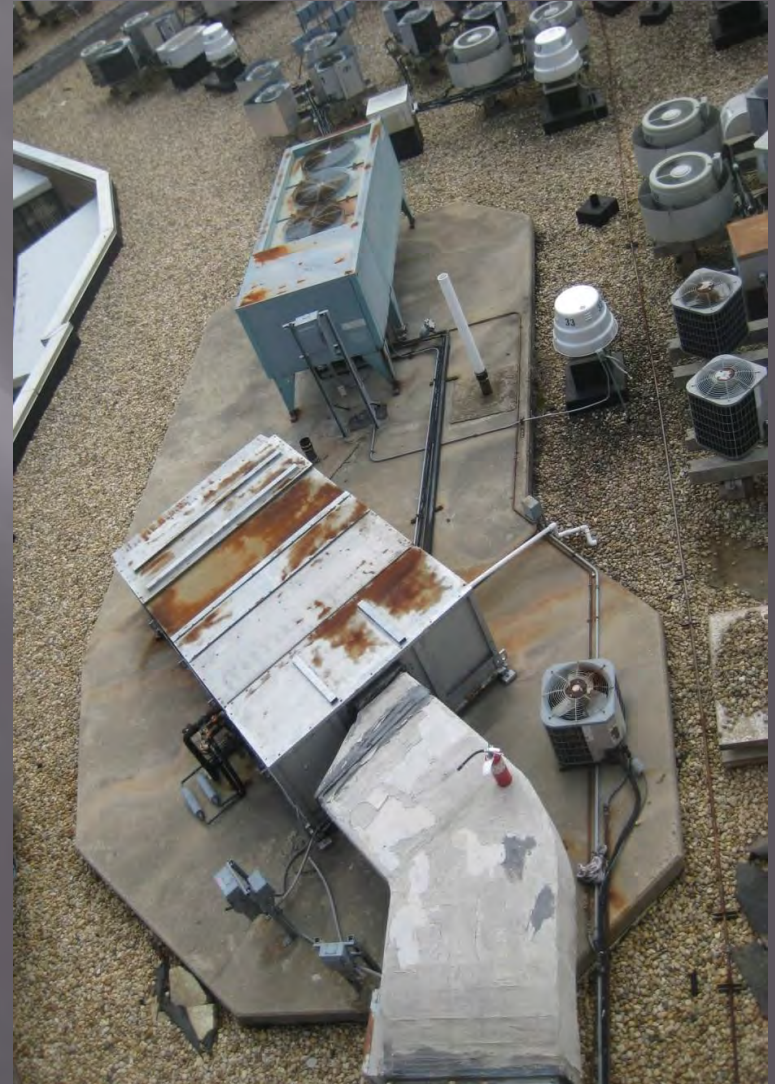
- Three (3) split-component air handlers

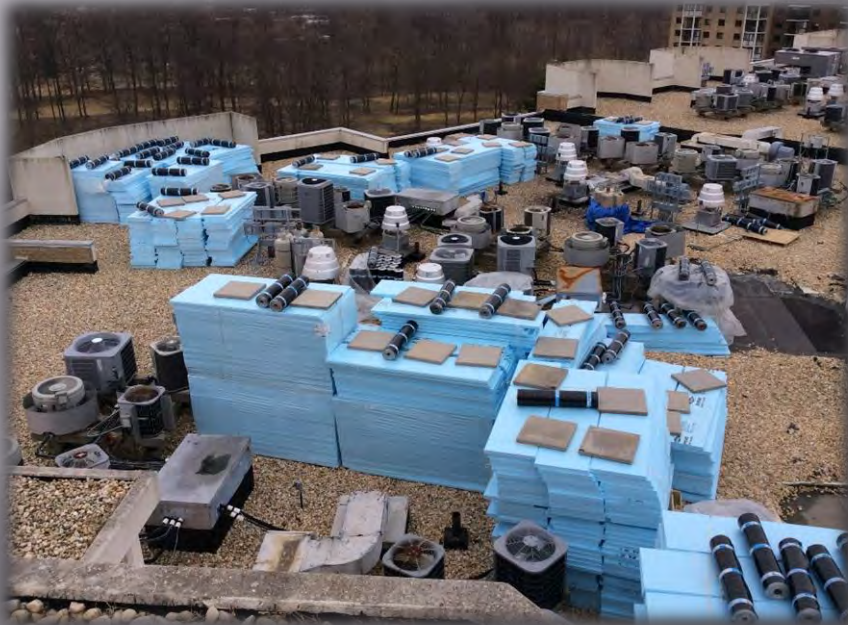
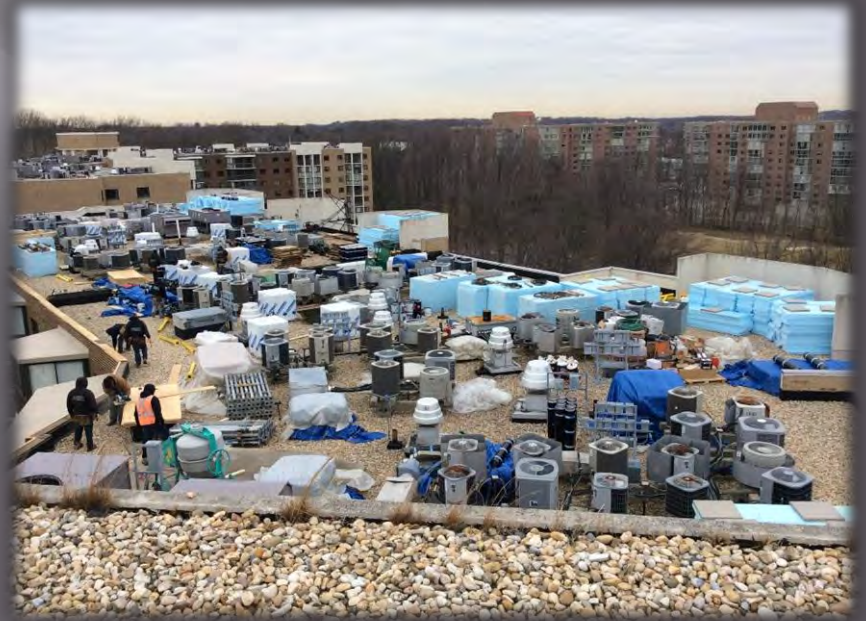
Congested Roof Areas

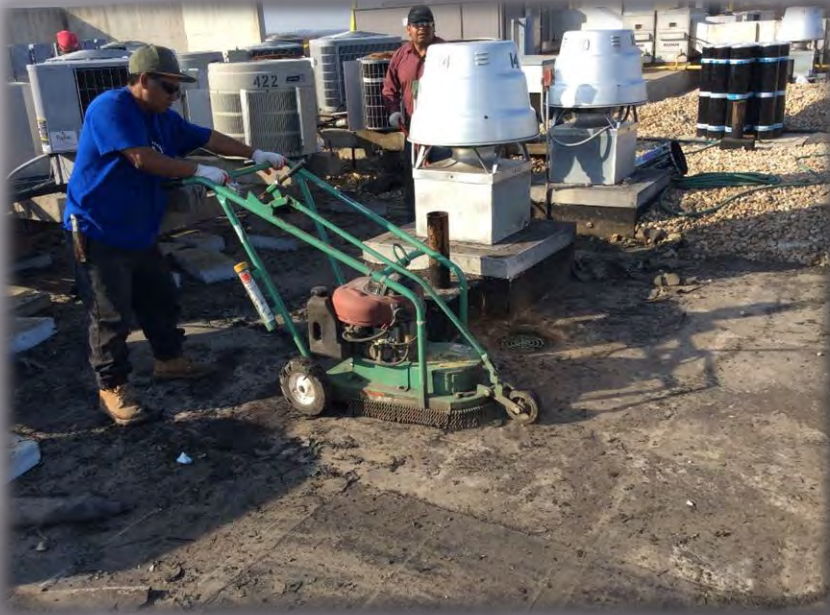
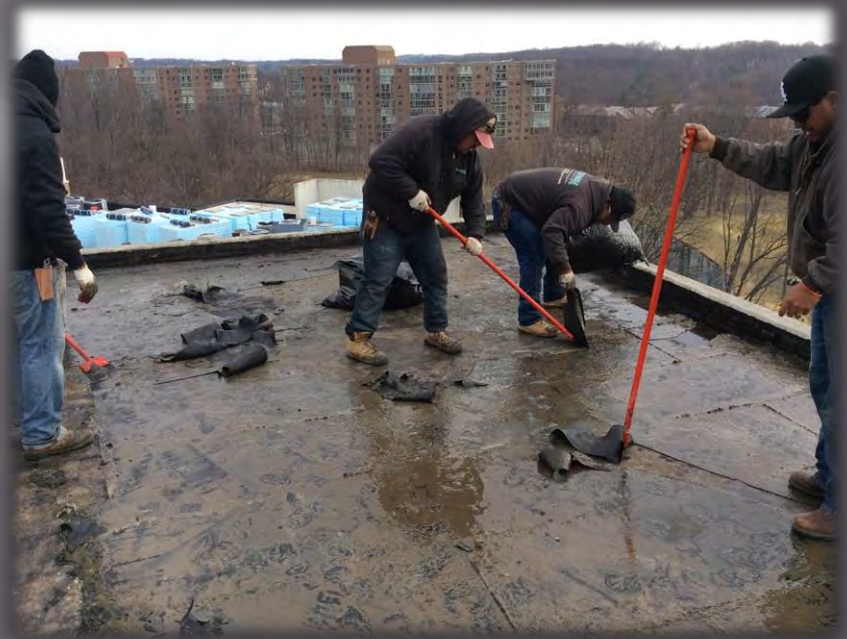
Roof Tear Off

- Remove old roofing materials down to the concrete roof deck.
 - Metal copings
 - Stone ballast (salvaged)
 - Filter fabric
 - Insulation board
 - Roof membrane and flashings

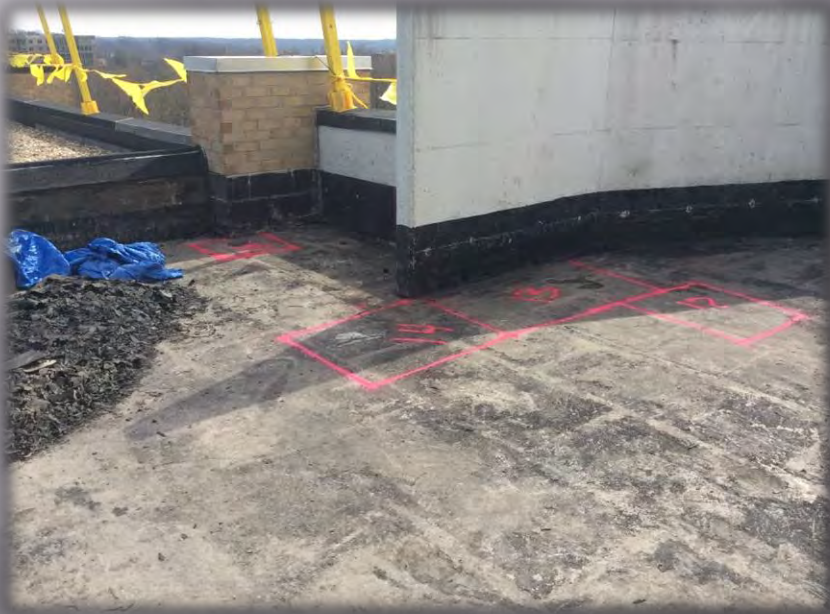
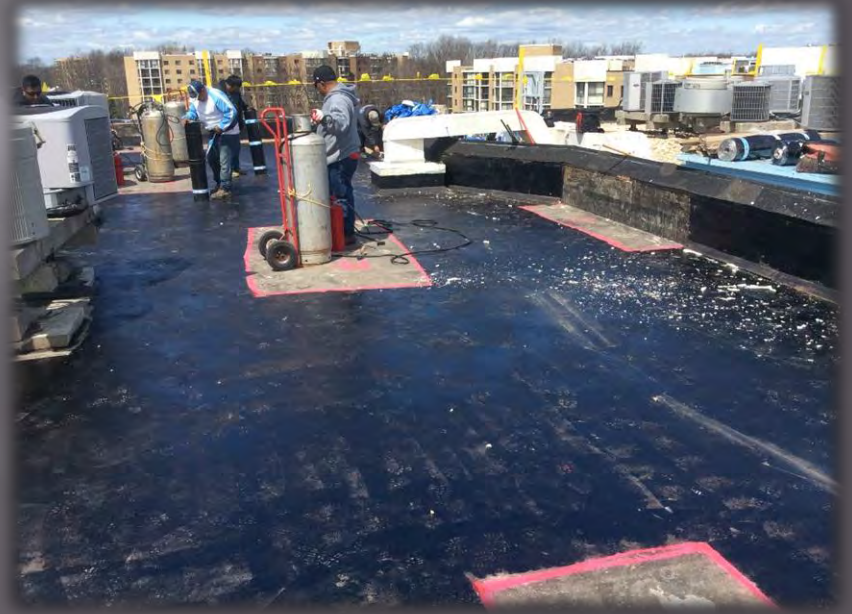
CONCRETE SOUNDING

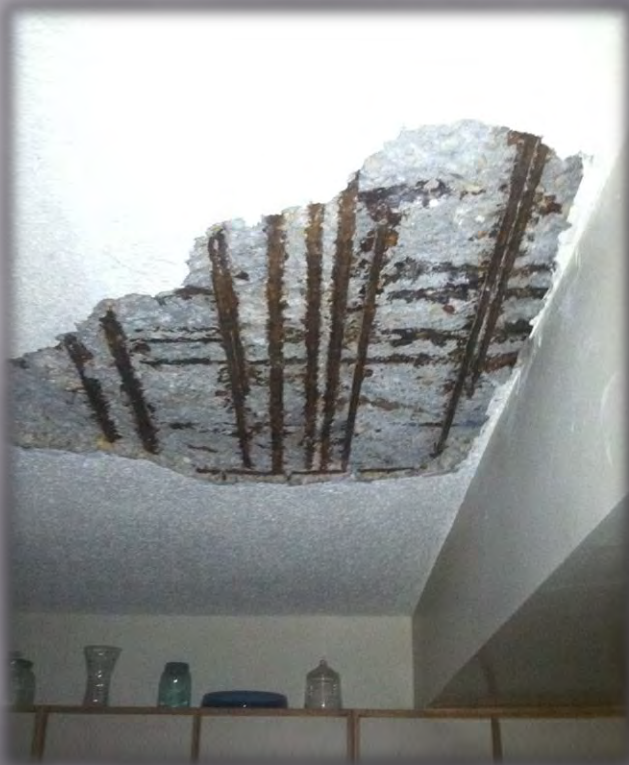
Demolition

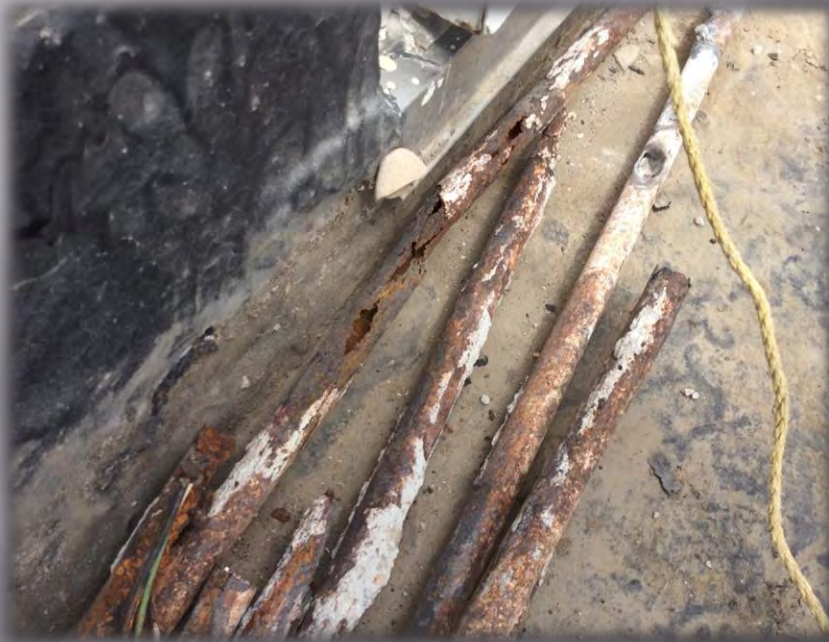
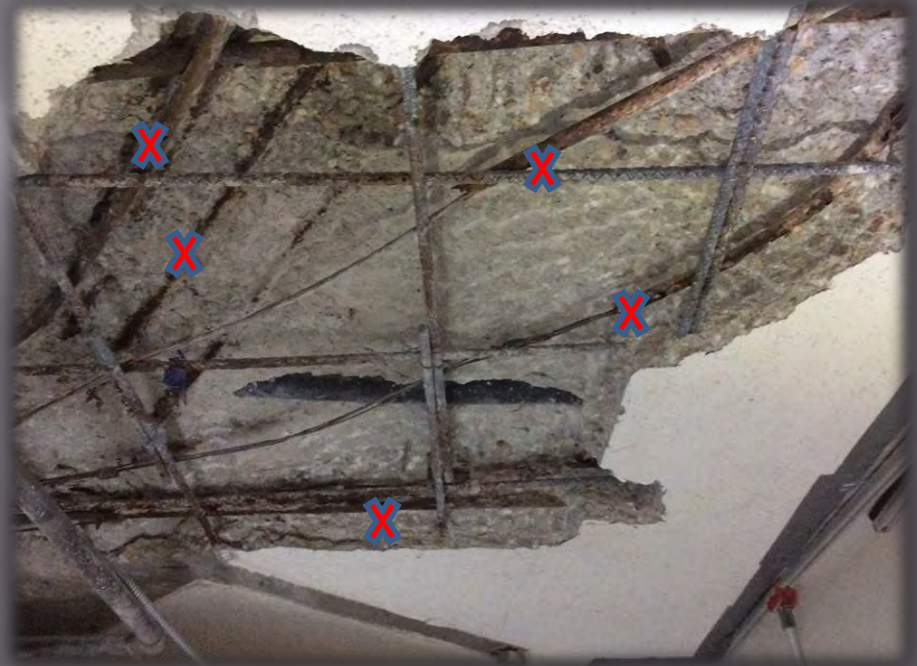
Embedded Electrical Conduits

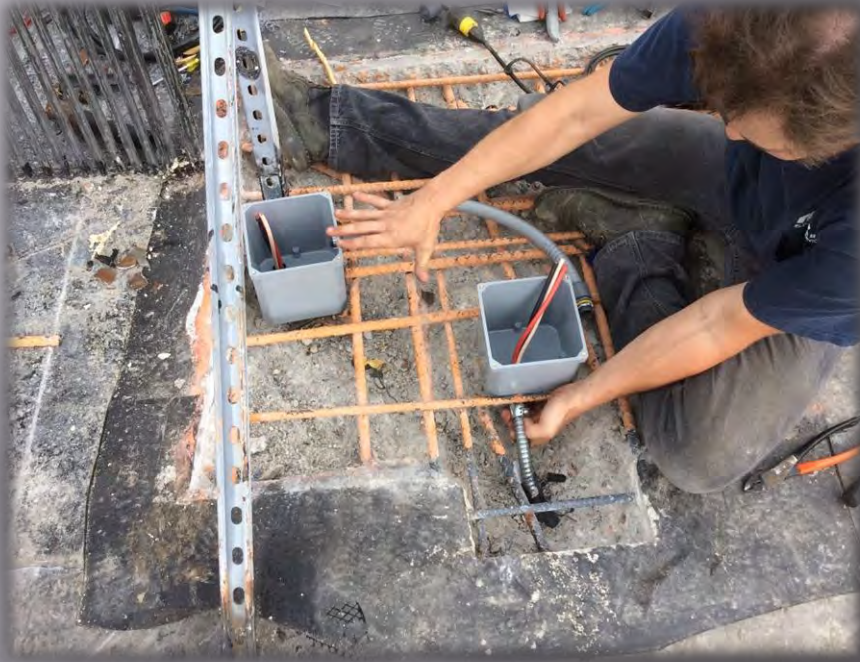
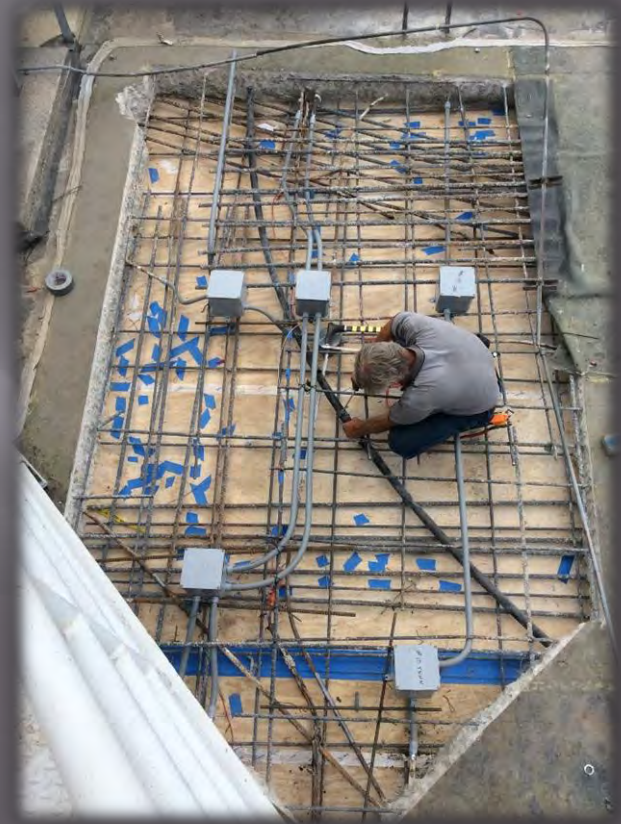
ELECTRICAL CONDUIT REPAIRS

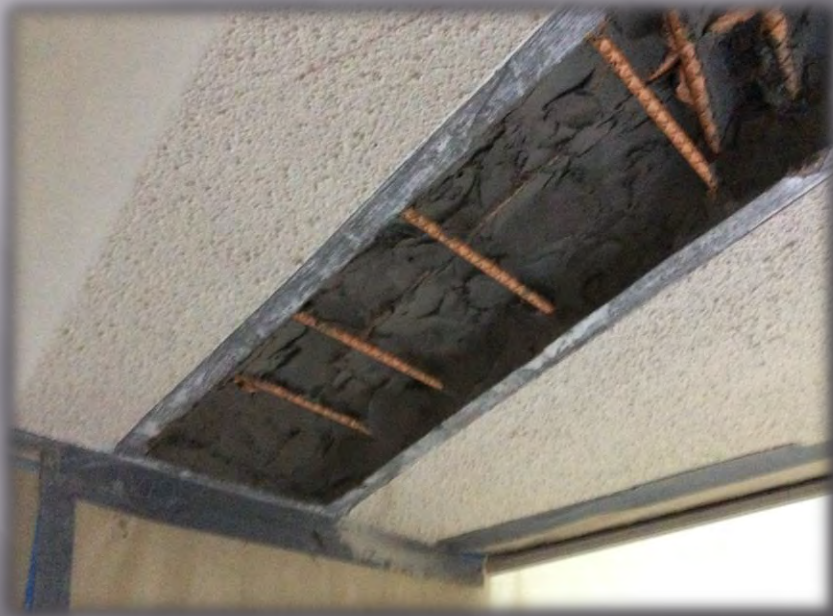
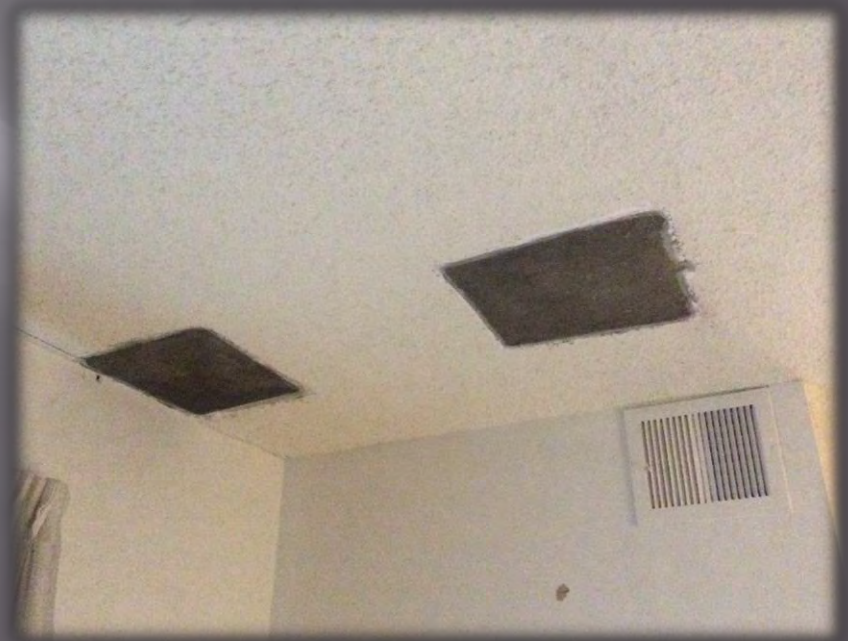
Trowel grade repair material

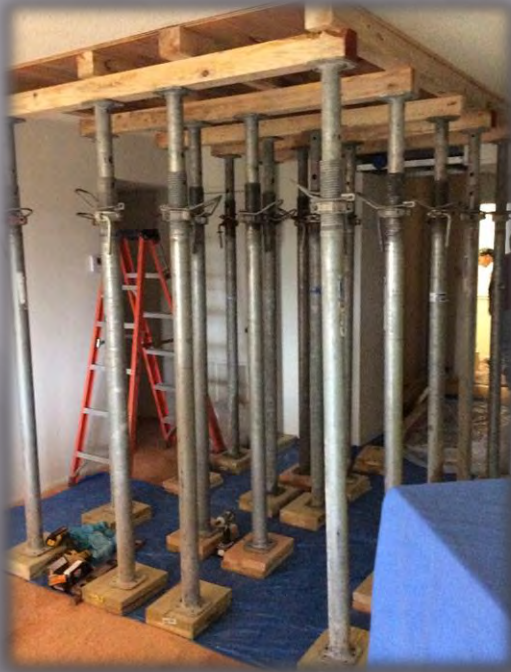
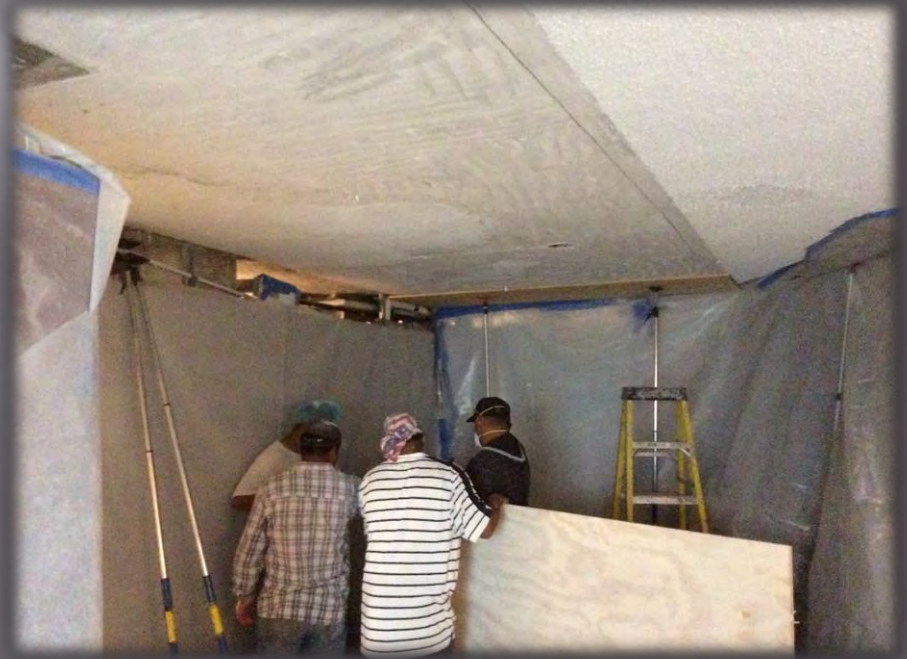
Shoring - 9th & 10th Floors

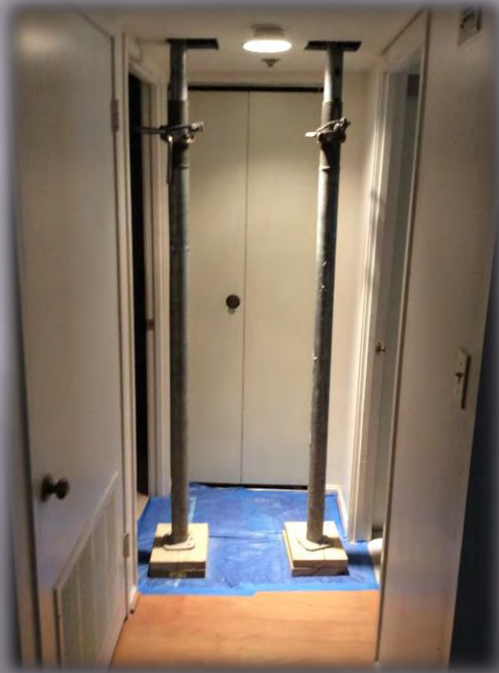
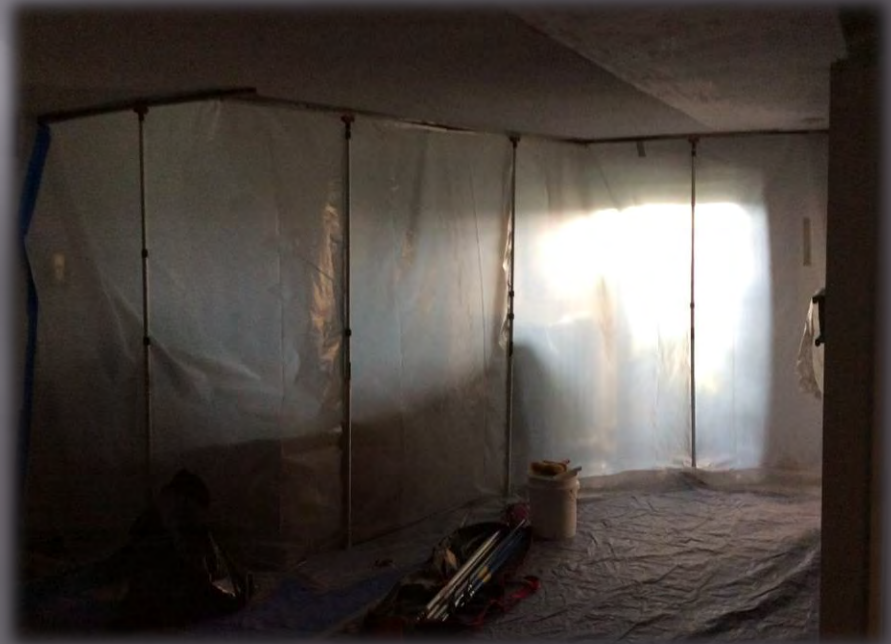
Shoring - 9th & 10th Floors

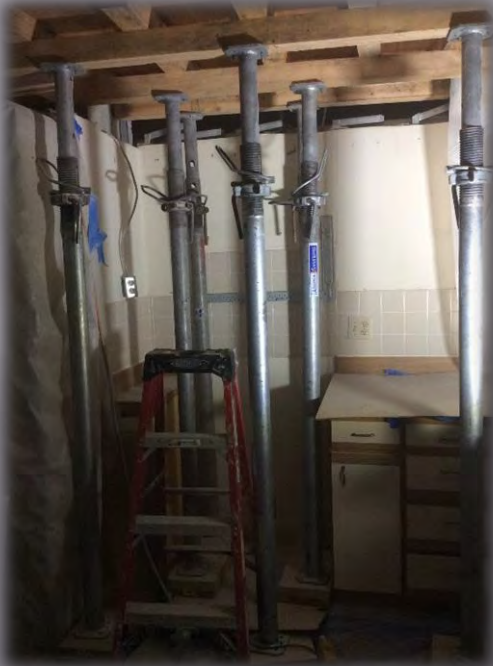
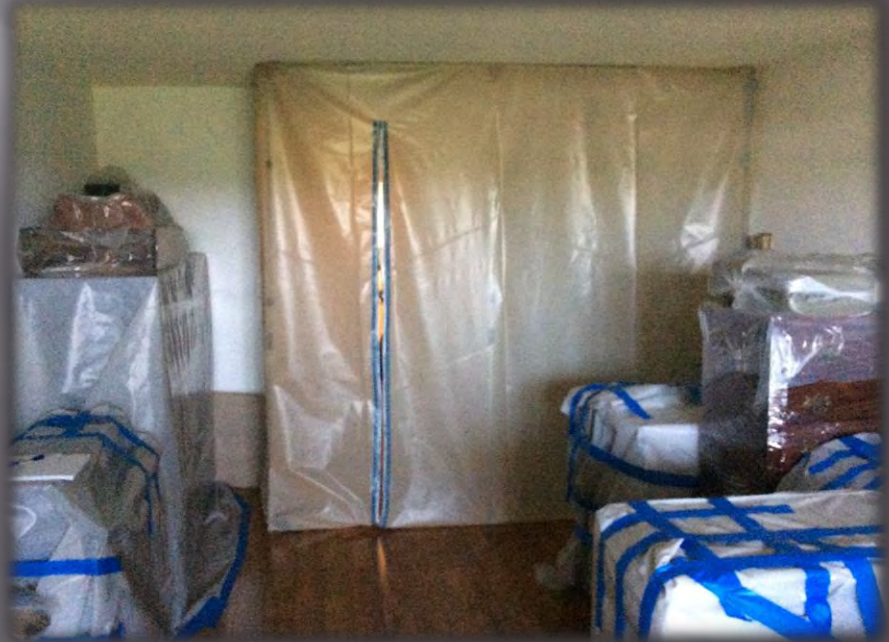
Shoring - 9th & 10th Floors

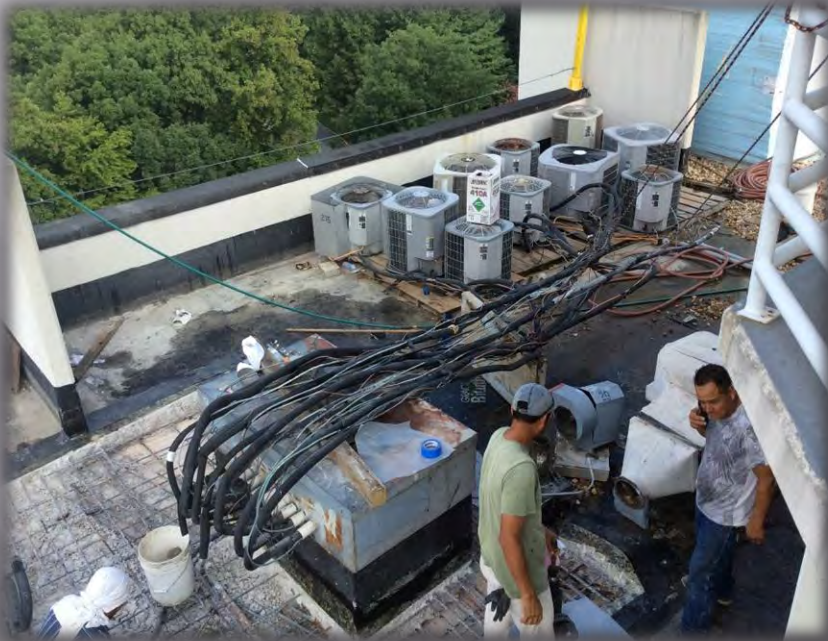
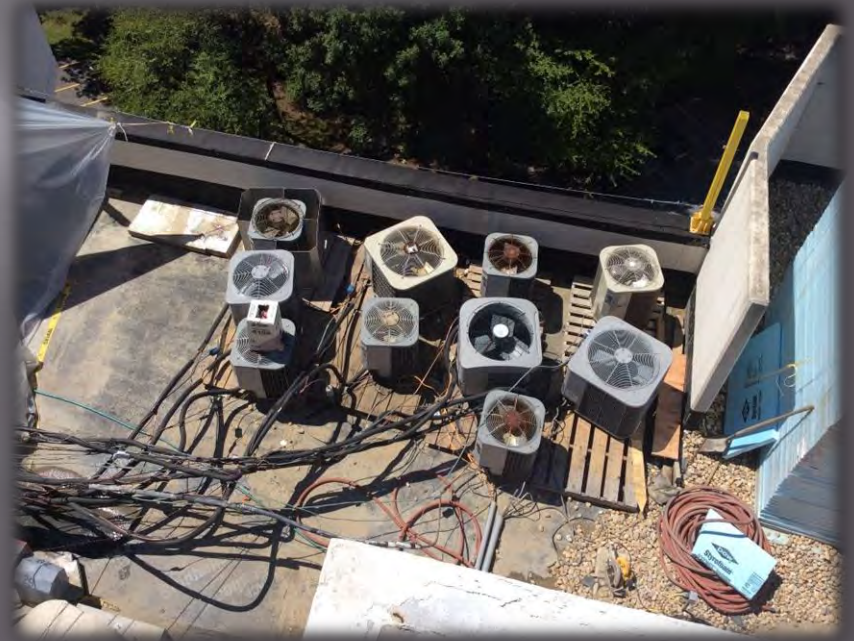
Relocation of heat pumps

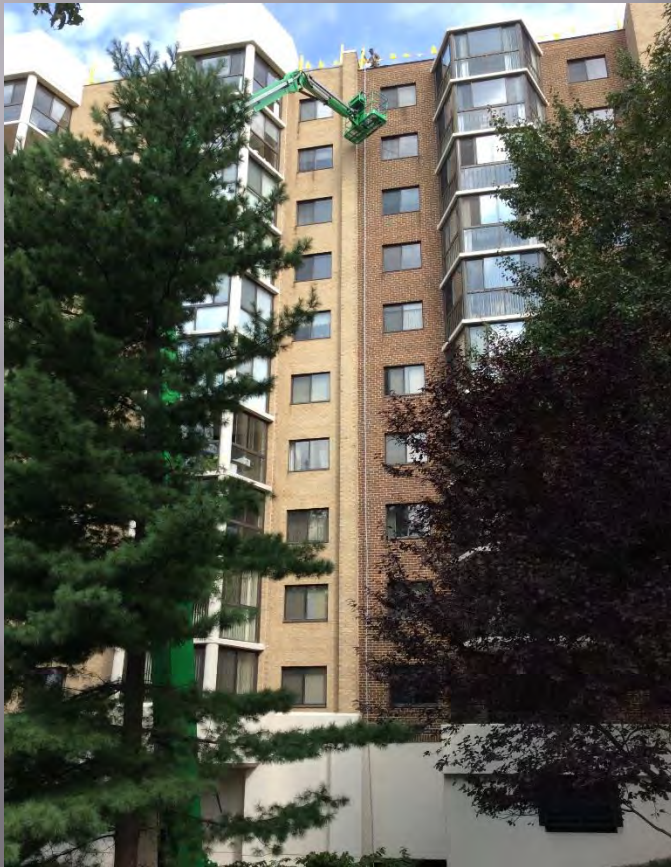
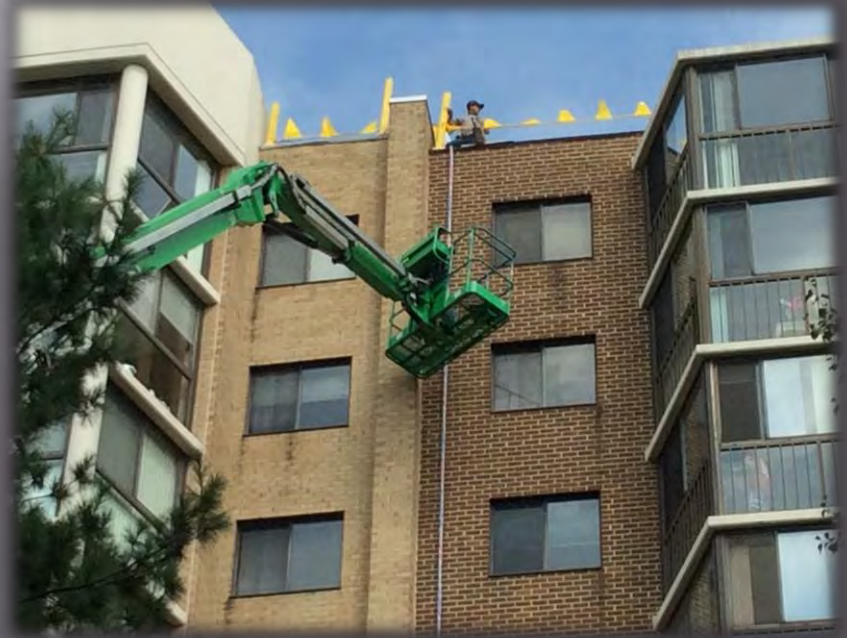
Elevator Temporary Power

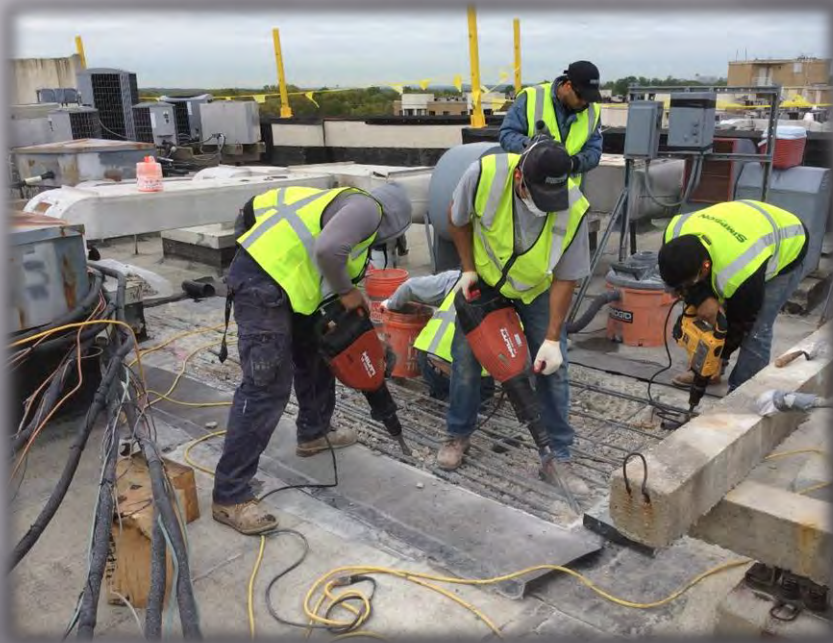
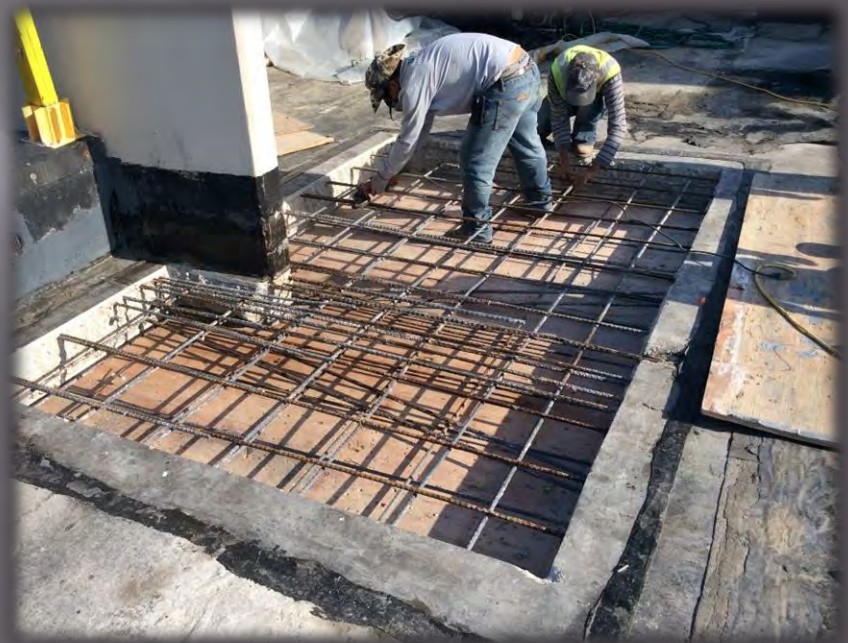
Concrete Demolition

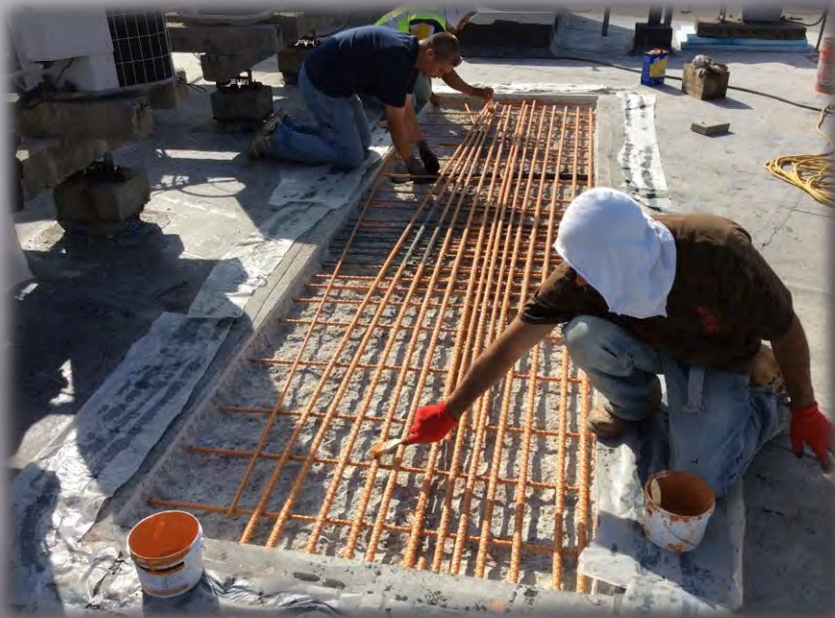
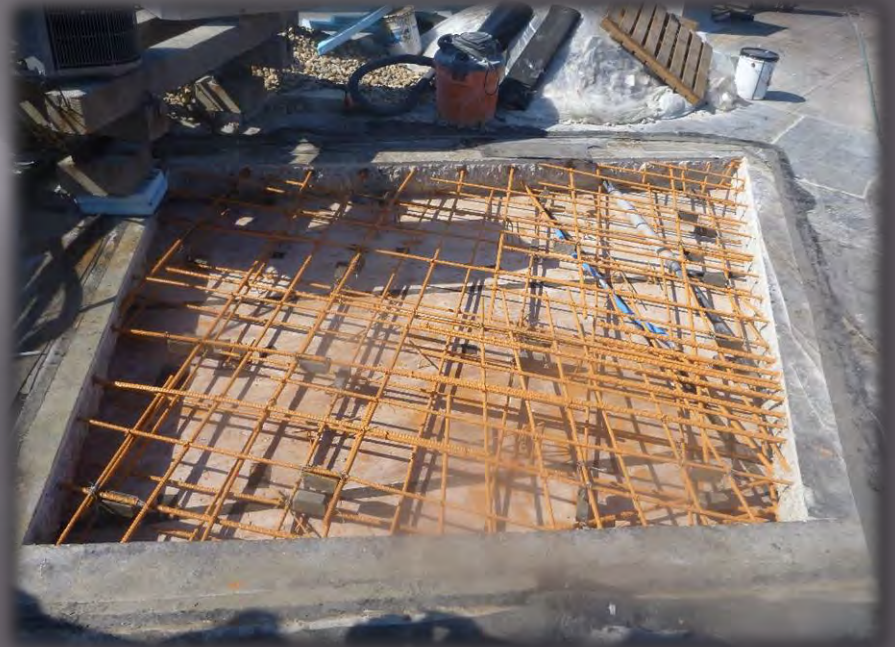
Reinforcing Steel Preparation

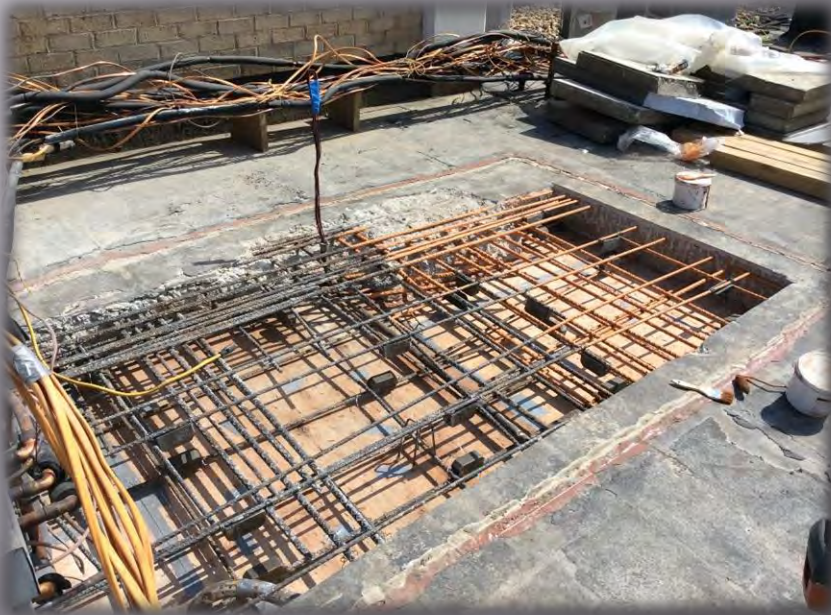
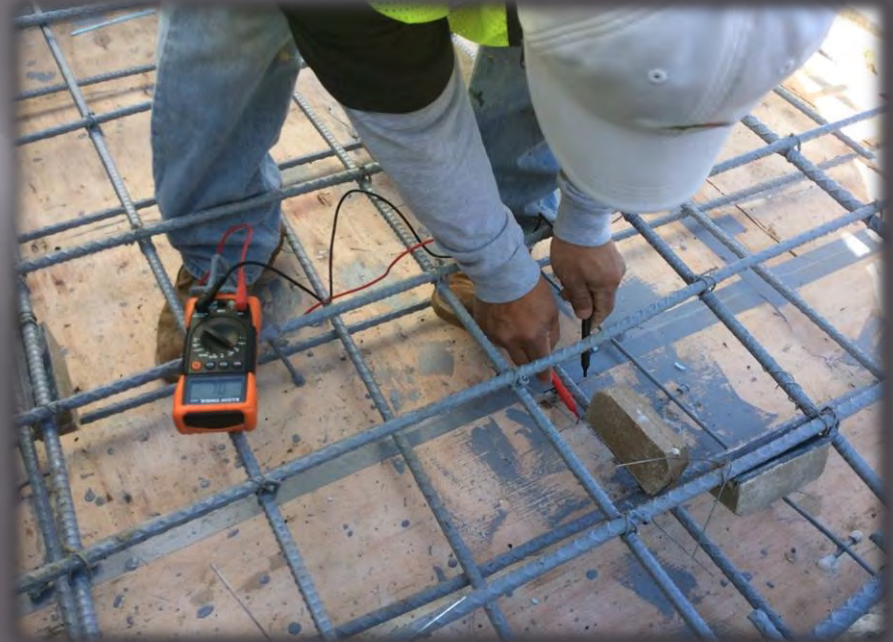
Cathodic Protection

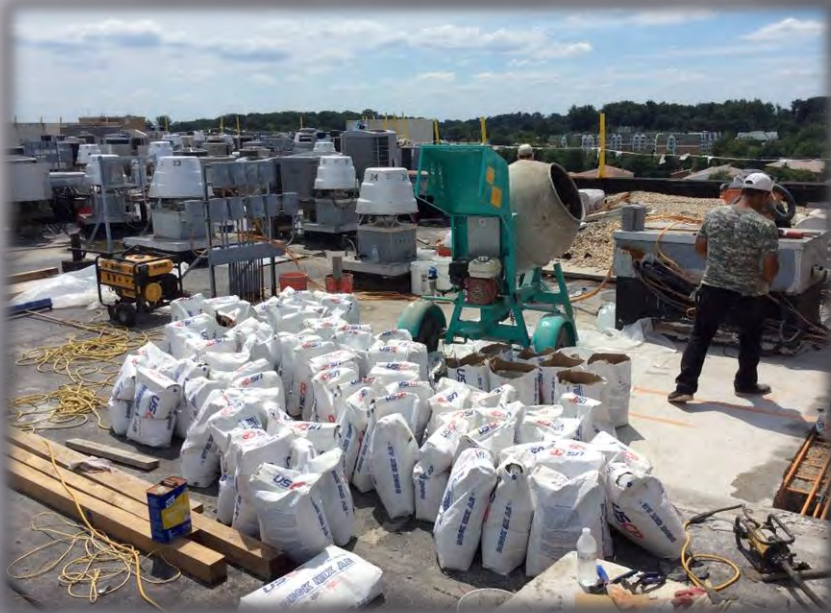
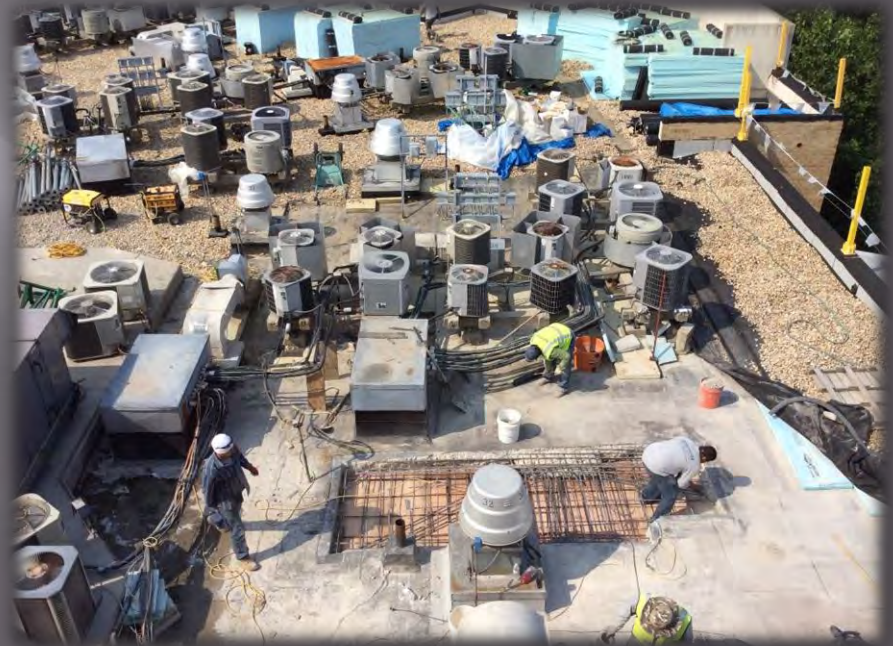
Concrete Placement

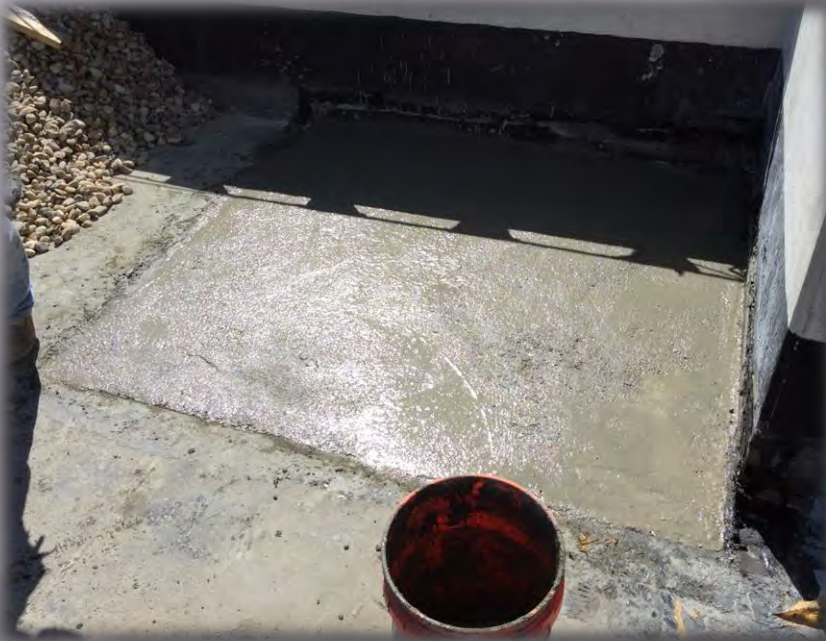
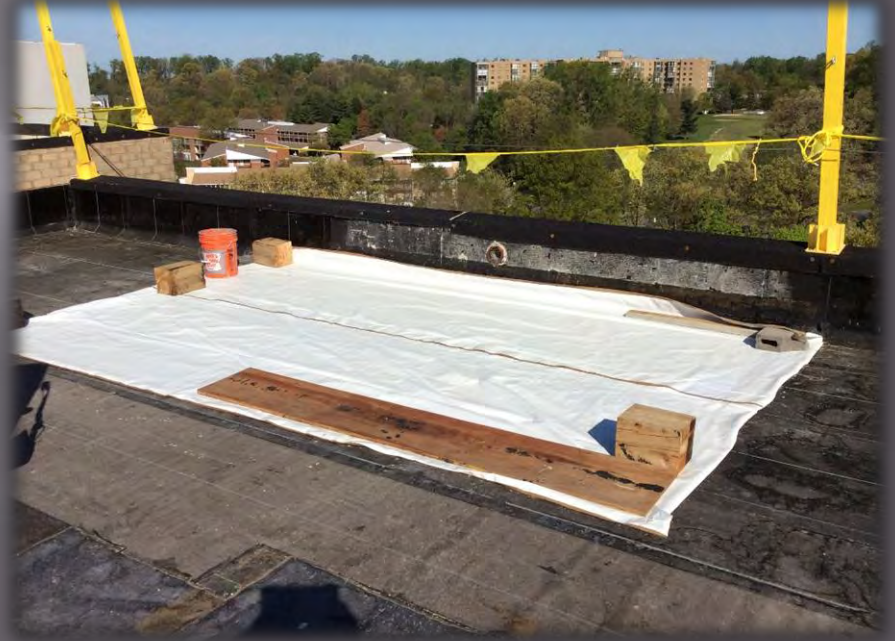
Concrete Placement

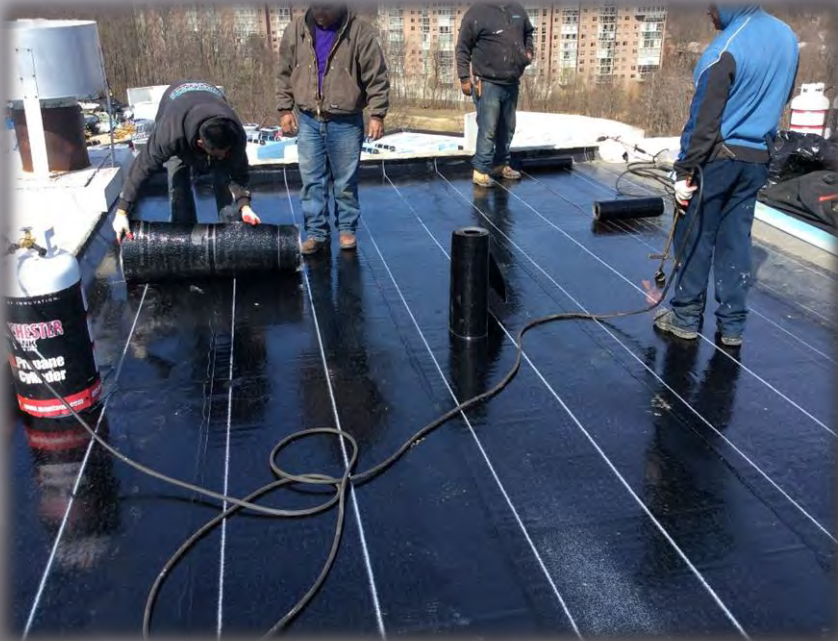
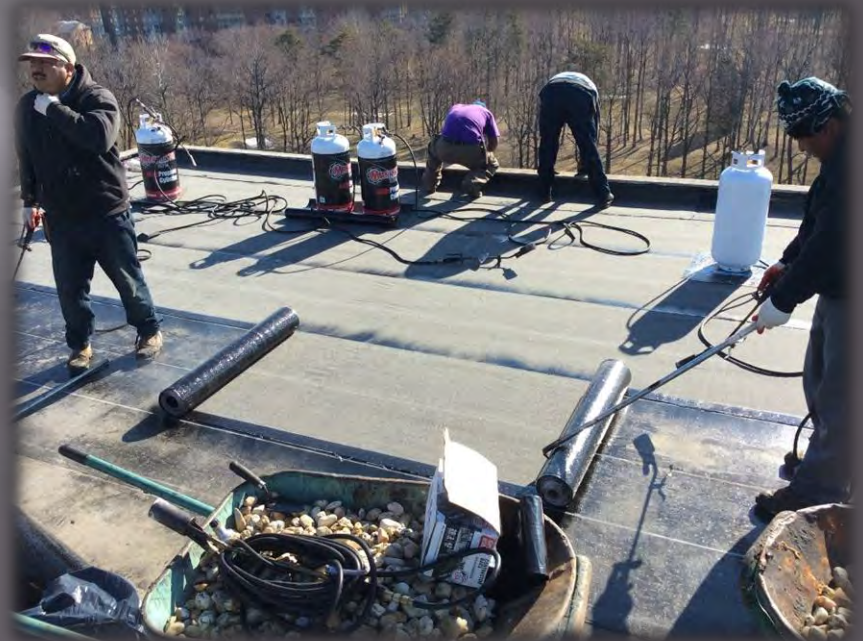
Field Plies Installation

- Clean and prime concrete roof deck
- Install (torch-apply) new two-ply roof membrane
- Remove and replace existing roof drains
- Install new insulation board
- Clean and reinstall stone ballast
- Install new expansion joints and metal copings
