GREENS AT LEISURE WORLD

15107 (Building #2) Interlachen Drive
Silver Spring, MD

ROOF REPLACEMENT PROJECT

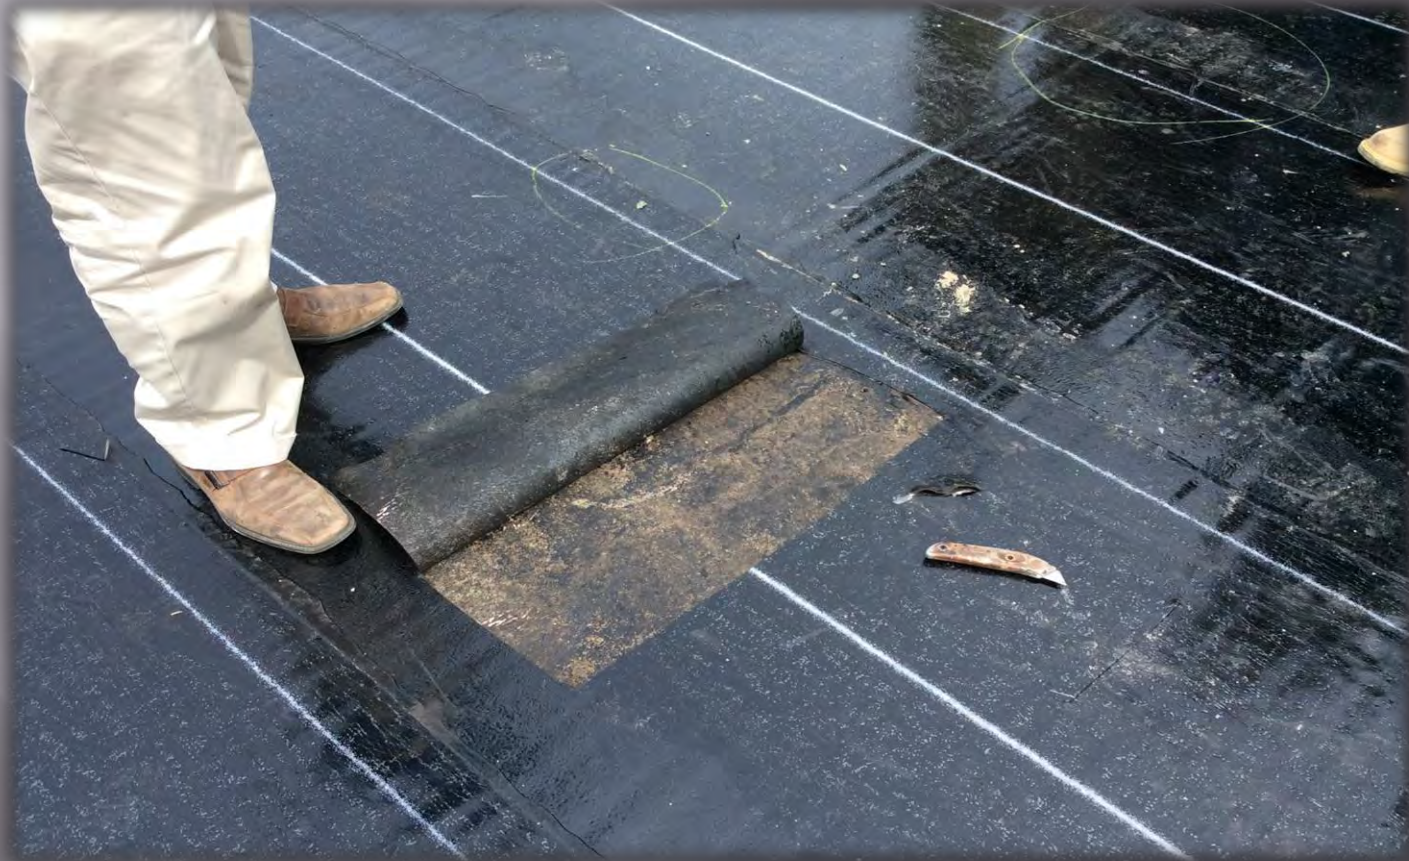
Field Test Cuts

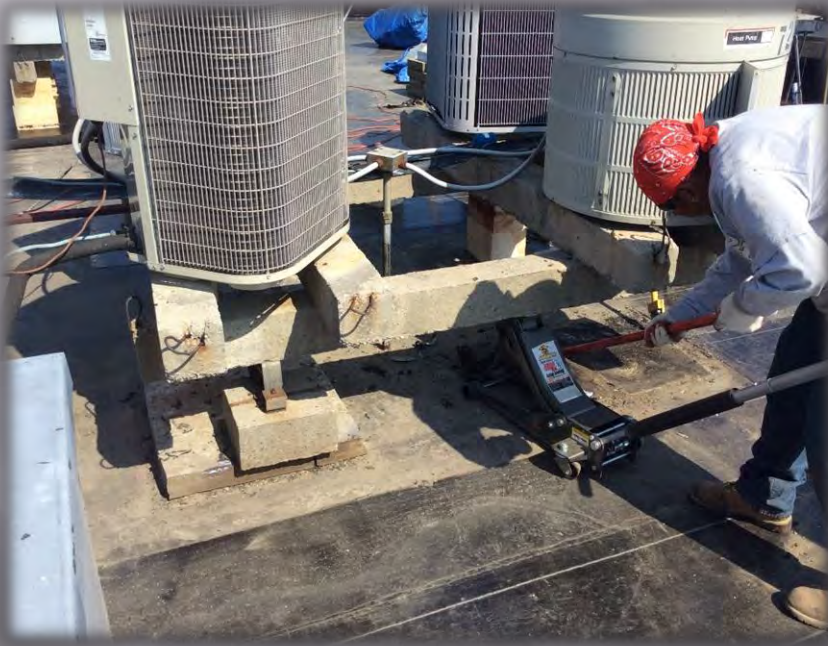
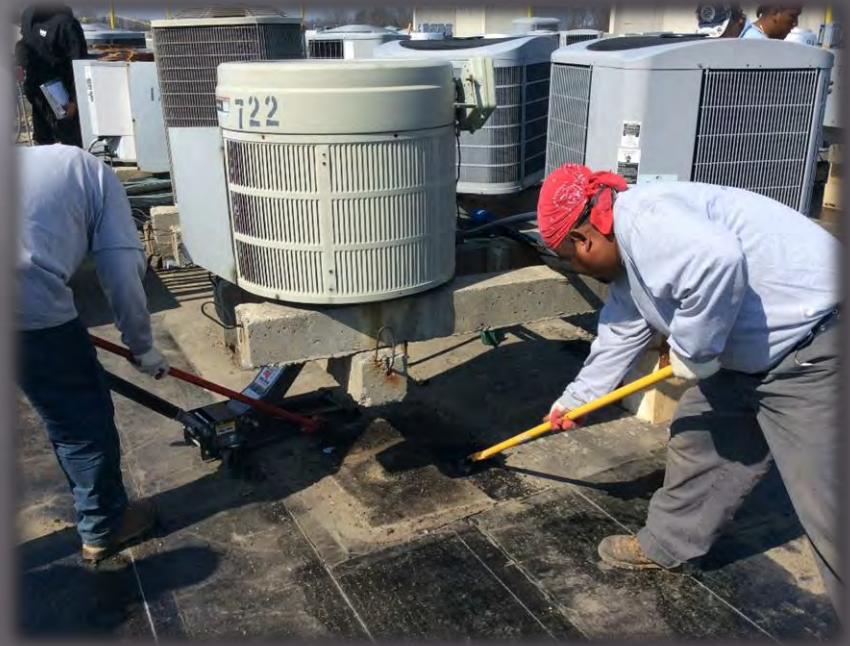
Raising & lowering of heat pumps

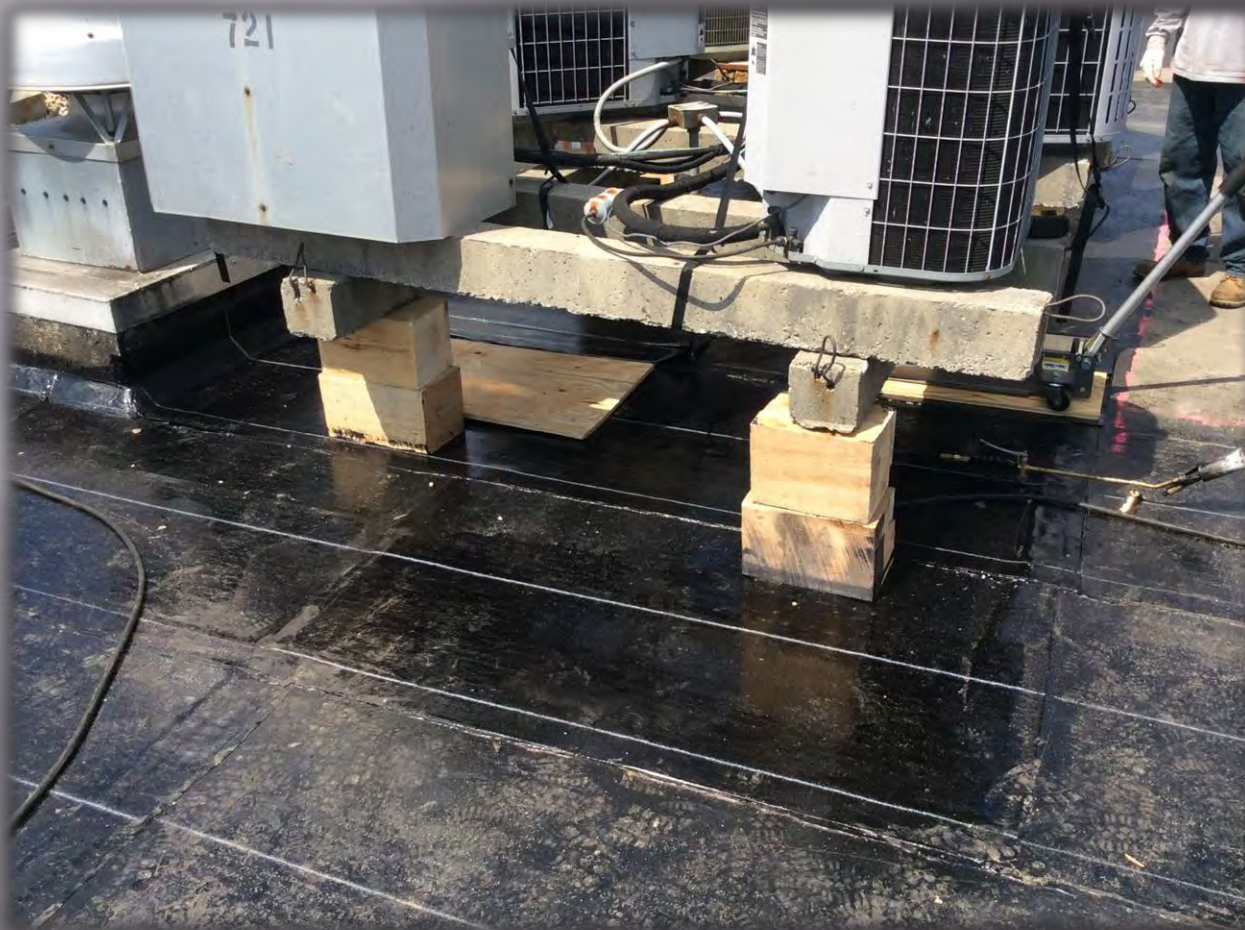
Raising & lowering of heat pumps

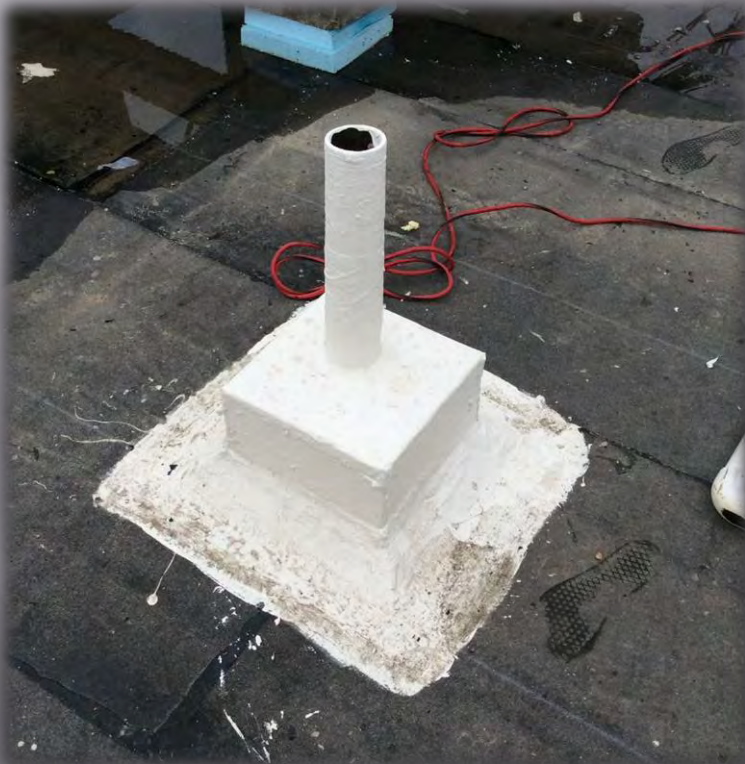
PMMA Flashing Installation

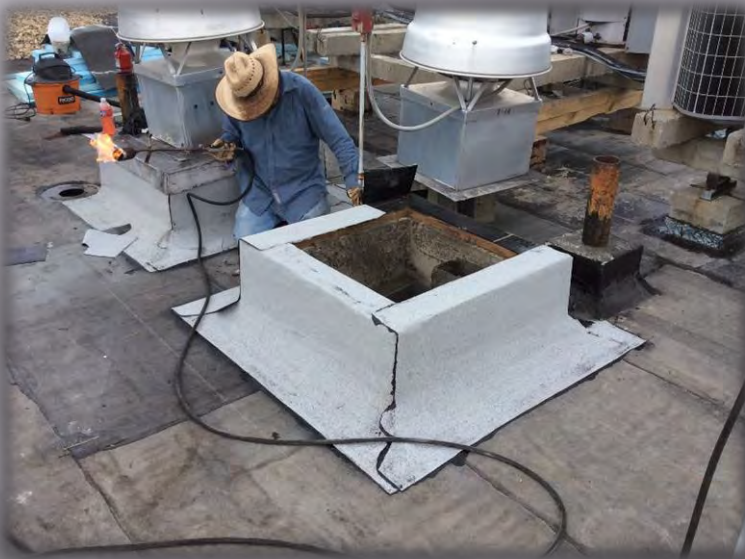
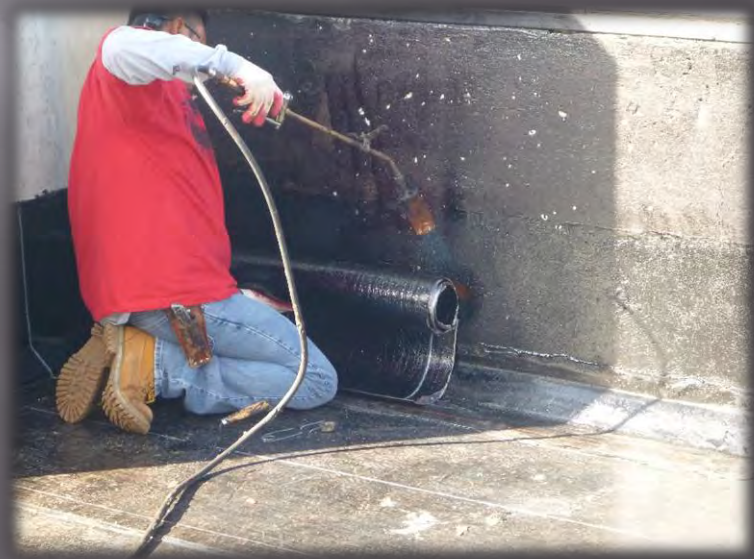
Membrane Flashing Installation

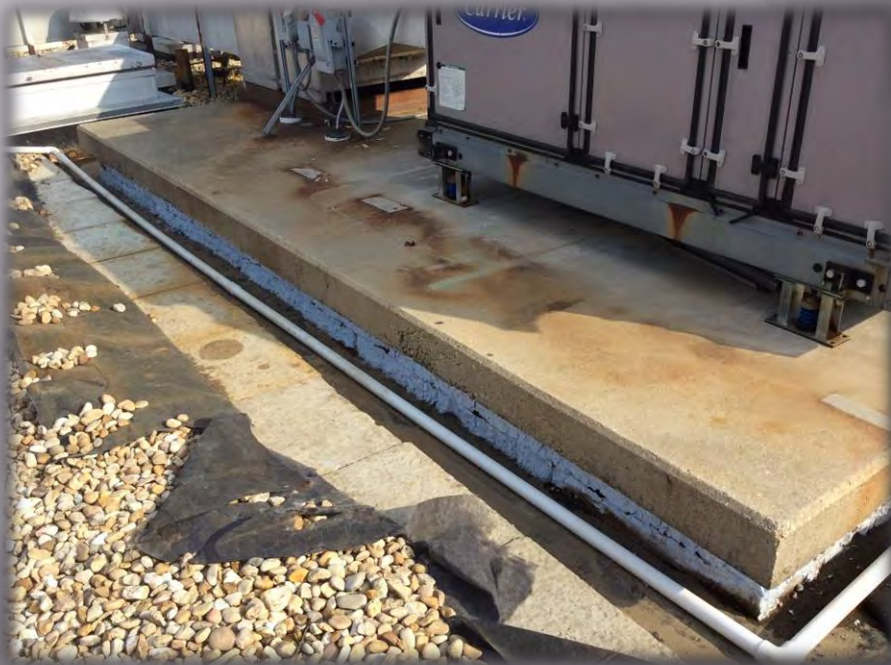
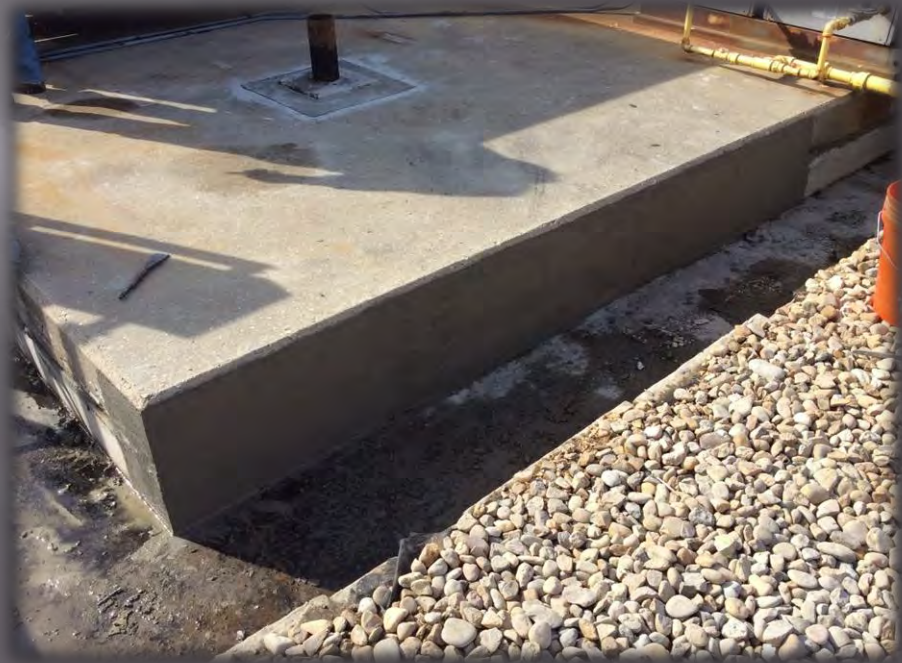
Air Handler Flashing

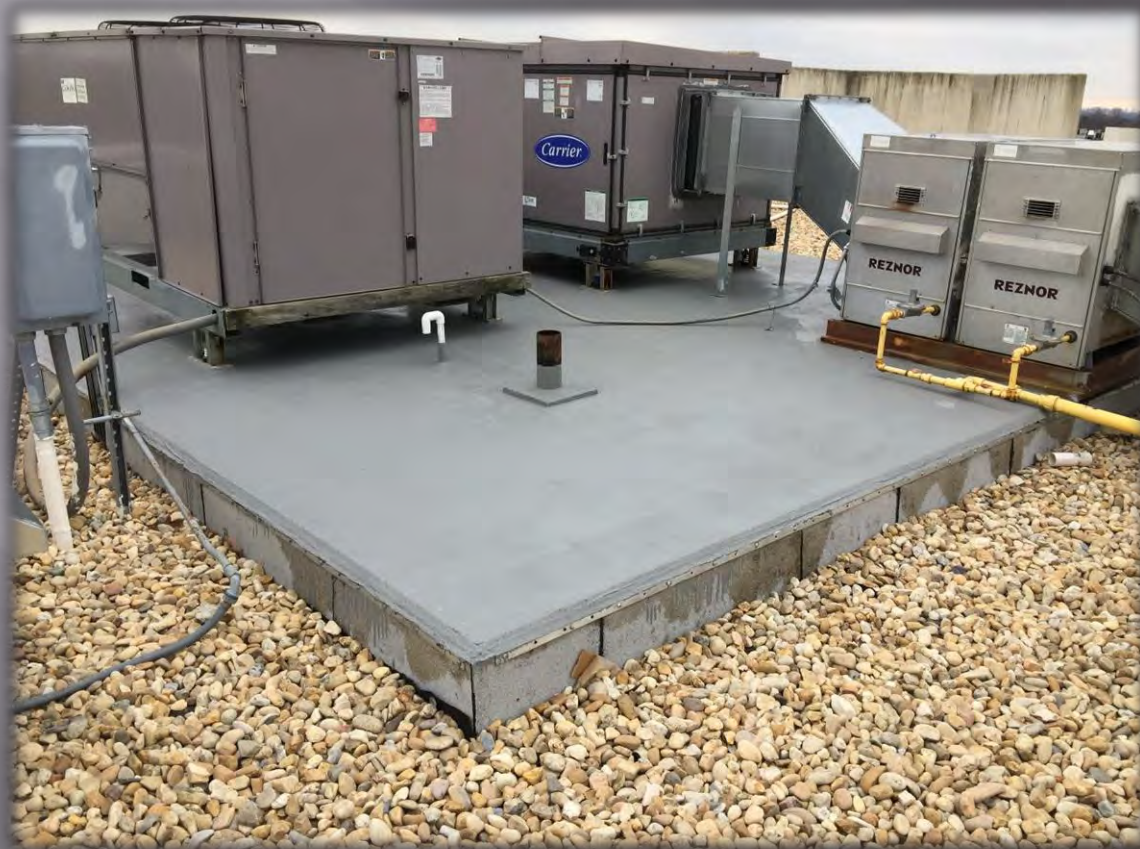
Air Handler Flashing

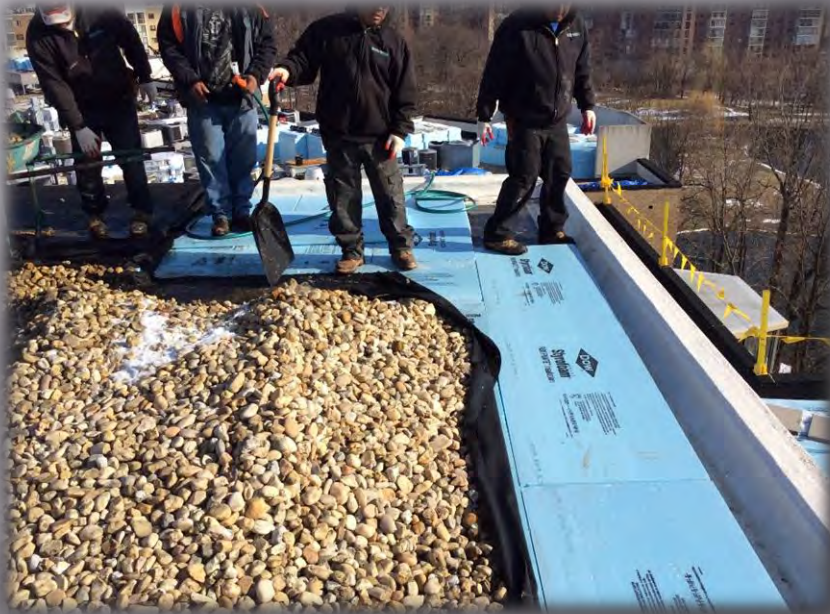
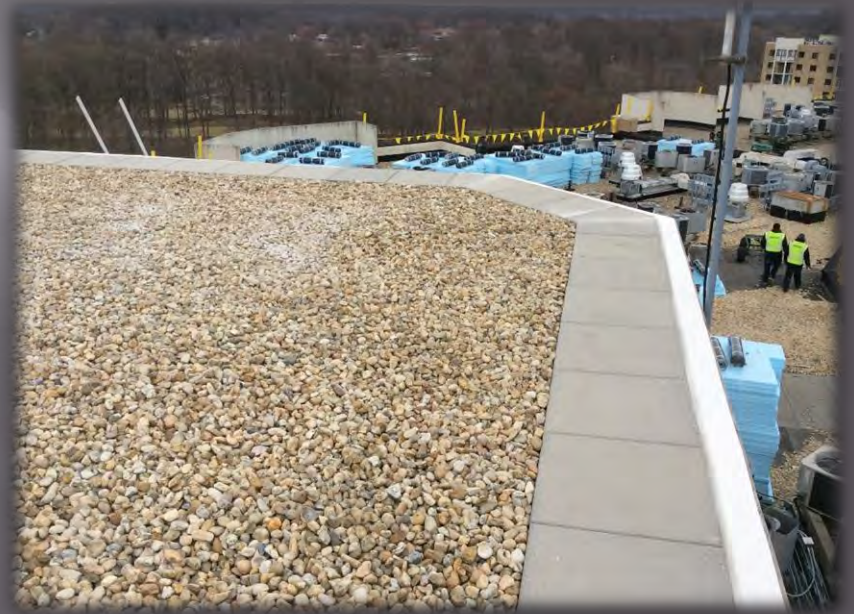
Overburden Installation

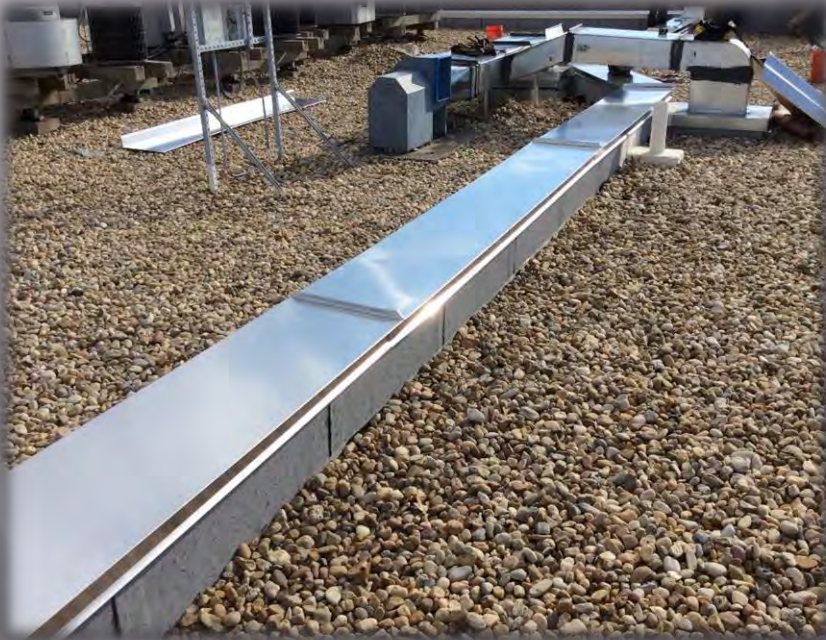
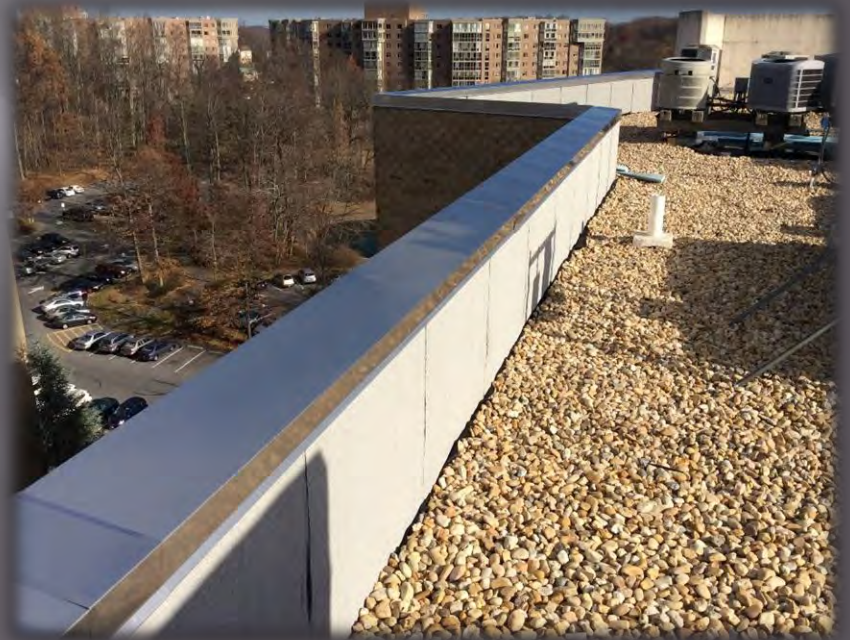
Metal Work

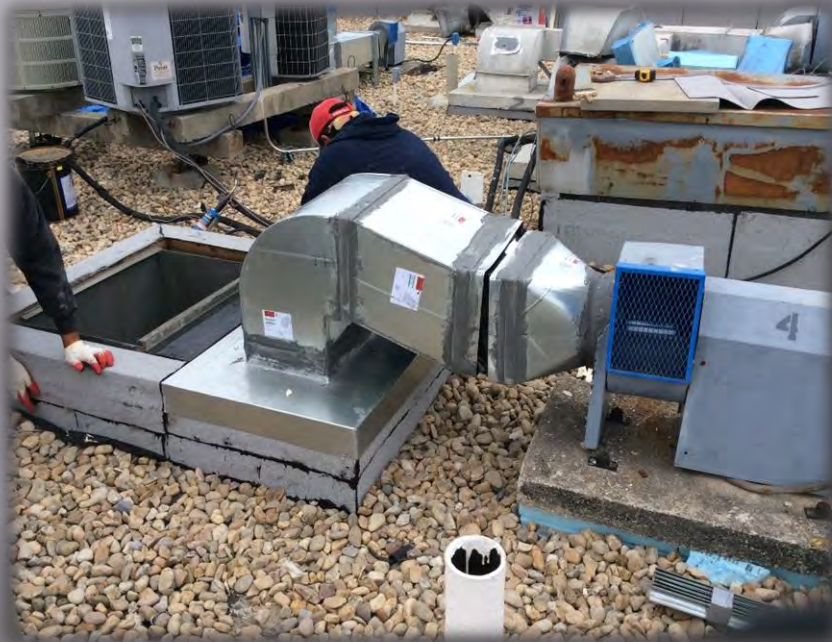
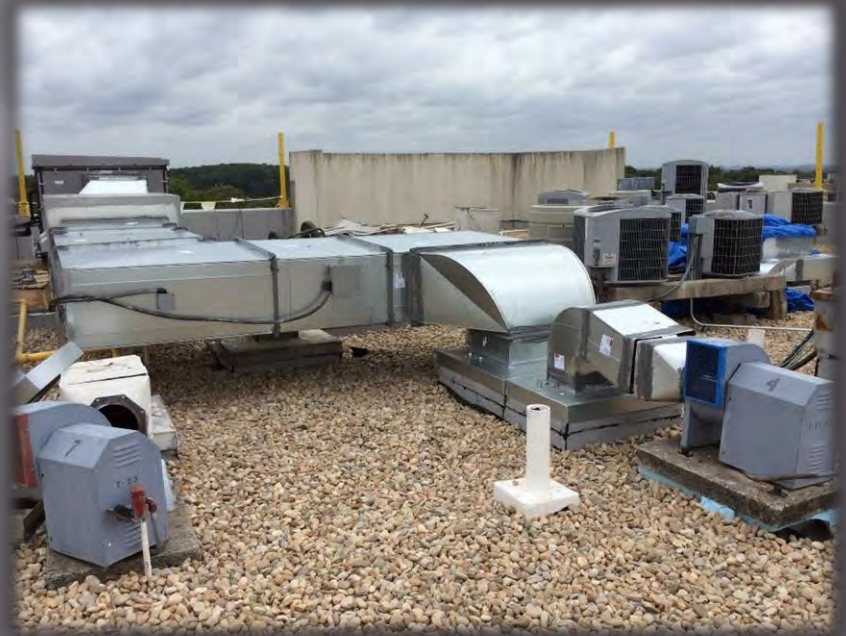
Replacement of Rooftop HVAC Ductwork

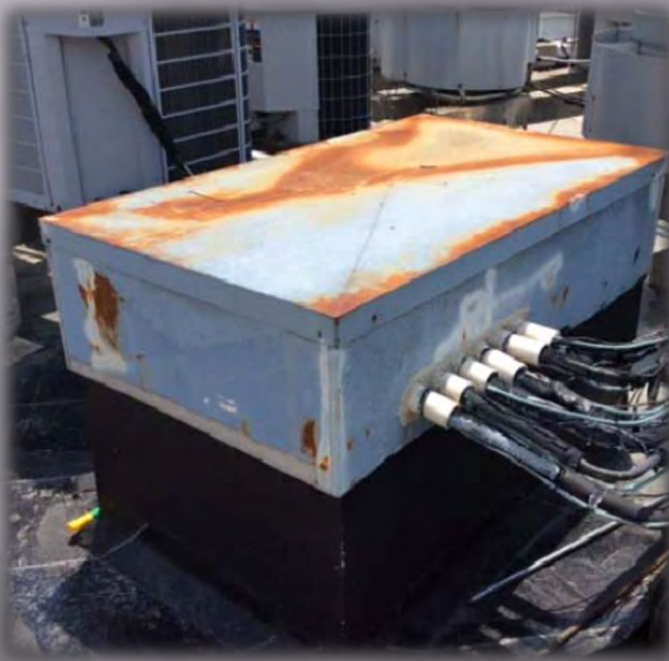
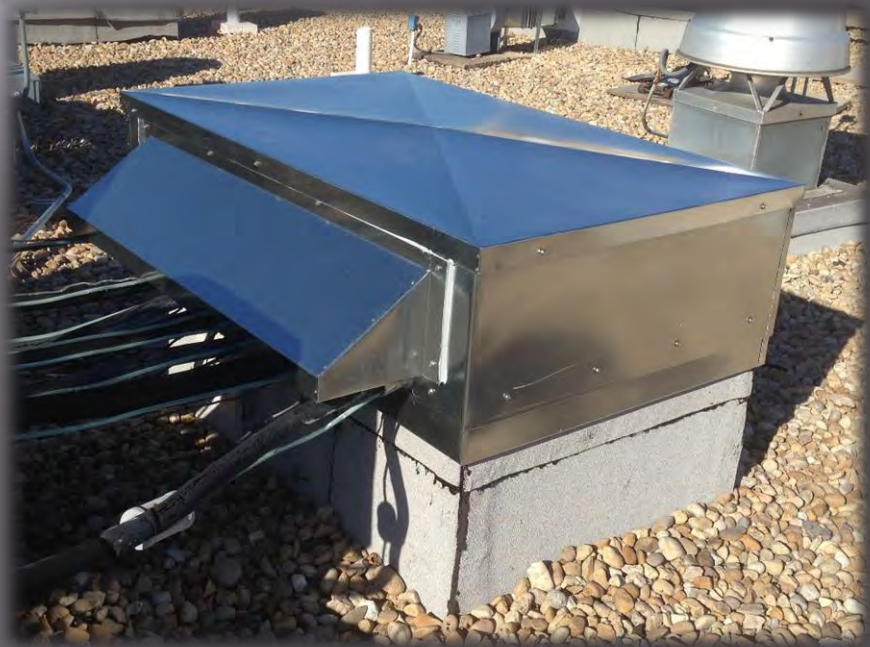
Replacement of Metal Chase Covers
