NOW THAT'S A DIRTY WINDOW JOB

When does a simple window replacement project take a turn and become a complex (dirty) job? The following chronicles a winding tale that started when the owners in a nine (9) story condominium located in Alexandria, Virginia, built around 1965, wanted to replace their original windows and large sliding glass doors. As is typical of older windows, they were drafty, some leaked water, and all were energy inefficient by current standards. Residents even said that the windows and balcony doors shook during storms and high winds. The building was not defined by any particular style of architecture, but the systematic rhythm of ribbons of windows and balconies suggested a thoughtful and modern design of the 1960s.

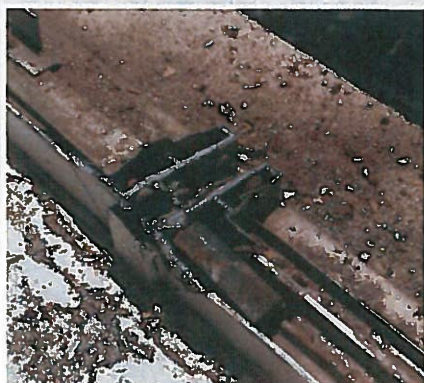
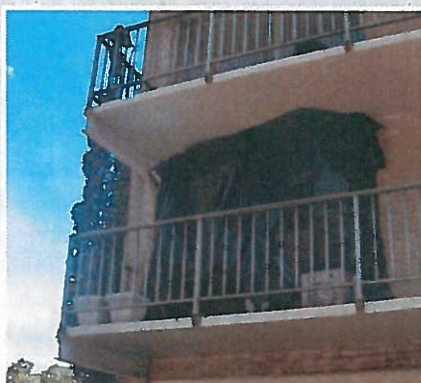
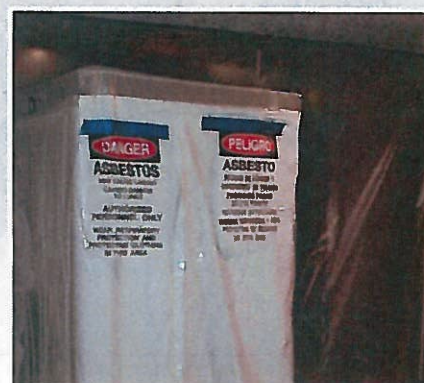
material is often found to contain asbestos. All team members were immediately notified that asbestos was discovered and the search for an asbestos abatement contractor started. At this point, a simple window replacement project became very involved and much more expensive.

The mere existence of asbestos in the sealant around the window was not enough to trigger the need for abatement work, as the old window frames and sealant were not going to be disturbed due to the “jump the frame” installation method. If two mullions of the fixed windows did not have to be cut out to install the new windows (which would make the asbestos friable, i.e. create airborne dust), the asbestos abatement around the windows would not have been necessary. This is because it is generally acceptable to leave undisturbed asbestos laden materials in place and encapsulate the material. Since the new window frame would have contained the asbestos containing materials, it would be considered a form of encapsulation.
